# *Sellers Hall*

## Upper Darby, Pennsylvania

A report compiling the archival and architectural research of Sellers Hall, from the spring terms of 2010 and 2011. Prepared by the Architectural Archaeology Class of the Graduate Program in Historic Preservation—School of Design, The University of Pennsylvania.

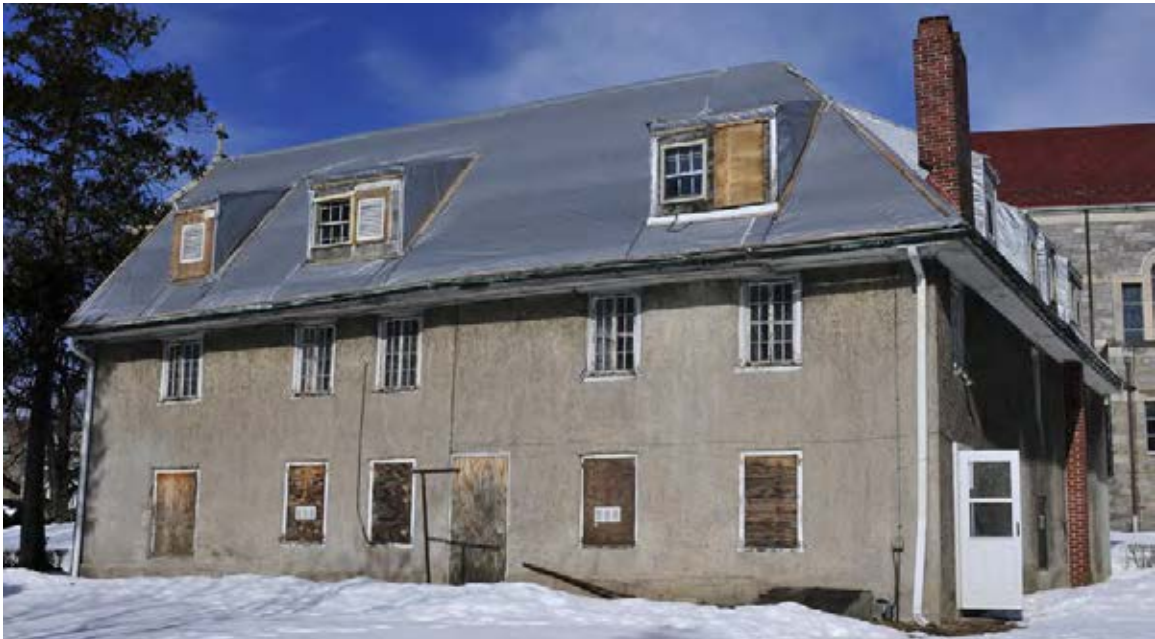
*Figure 1* View from southeast, 2010.

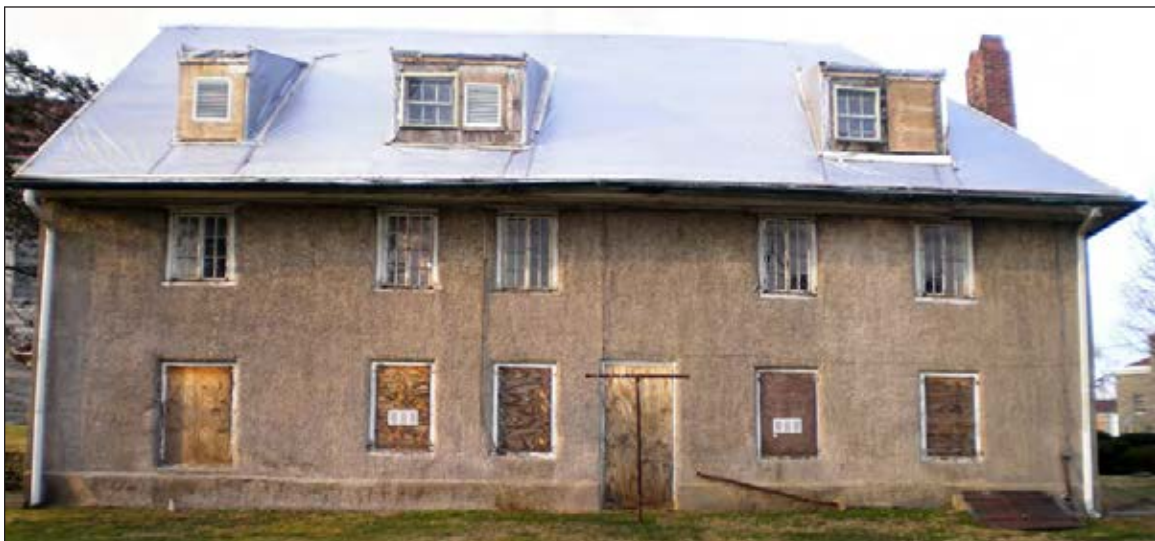
The south elevation, facing southeast onto Hampden Road, is five bays across. The fenestration is irregular and consists of various window shapes and sizes unevenly-spaced. All of the openings on the first floor (including five windows and one door) are covered with plywood. The first floor contains five six-over-six double-hung sash windows and a glazed French door. The second floor windows are casement windows. All except for the far west window have eight panes in each casement. The far west window has six panes in each casement. All windows have simple, wooden window surrounds and sills. The roof contains three large shed dormers. The two on the east side have two window openings each while the smaller dormer on the west has only one. A water table projects slightly across the façade, about 1' 6" from the ground. A brick chim-

*Figure 2* South elevation, 2010.

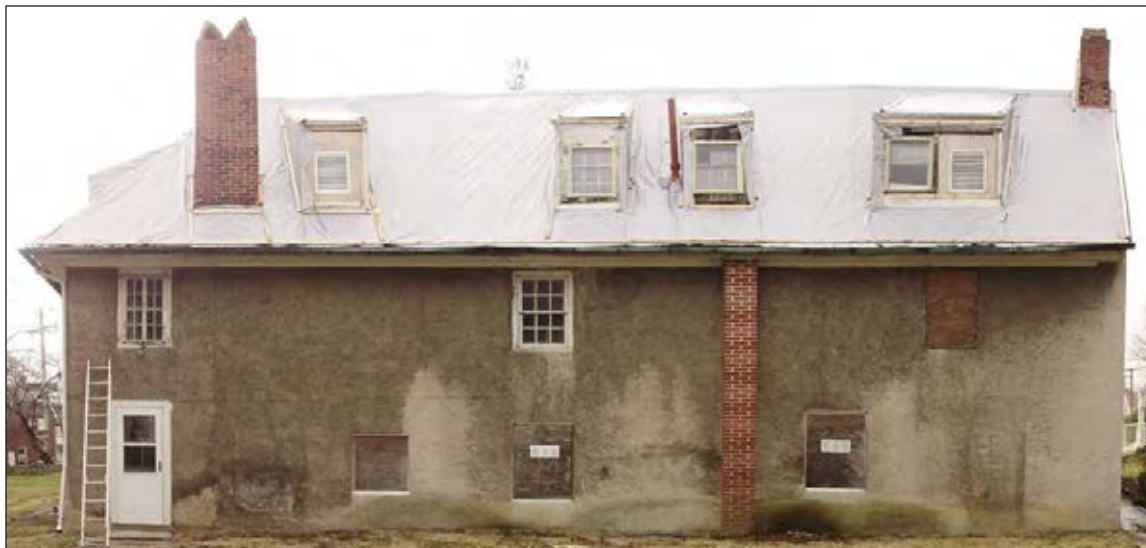
The east elevation is four bays across, also with irregular fenestration. A glazed door

opens in the south end of the façade at ground level. The three double-hung sash windows on the first floor are covered with plywood and the second floor contains one sixteen-pane casement window and one six-over-six double-hung sash window. Four shed dormers project from the roof, all with single windows except the farthest

**Figure 3** East elevation, 2010.

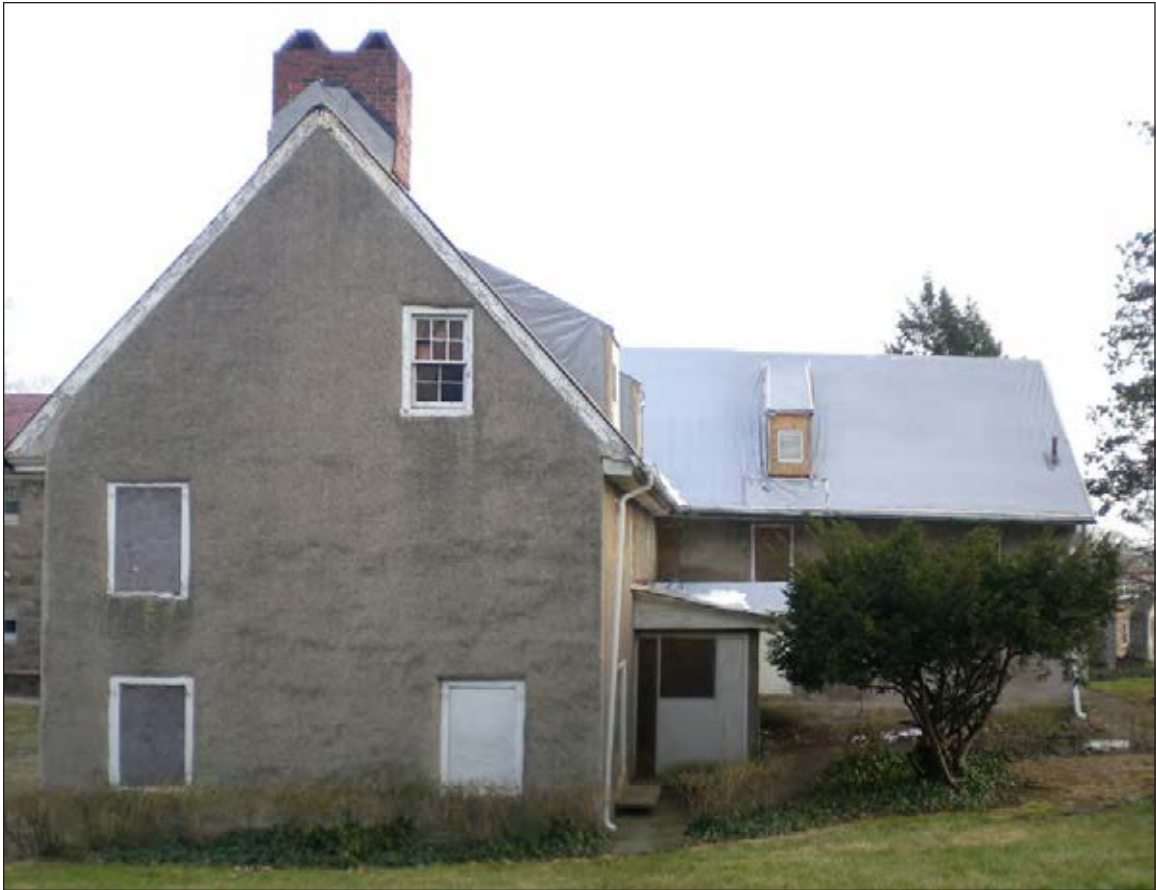
*Figure 4 North elevation, 2010.*

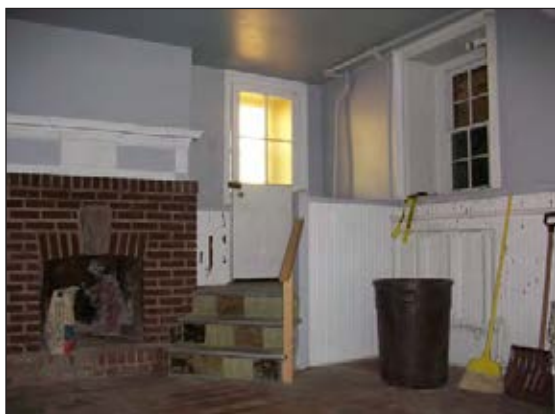
101: The room in the southeast corner of the first floor is entered from the exterior by a door in its east wall. Because of the lowered floor level, a 2' platform with three steps down provides access to the floor level. There is a fireplace in the east wall with a brick hearth built in front of an earlier wooden mantle. The room has two six-

Figure 7 Room 101, southeast entry, 2010.

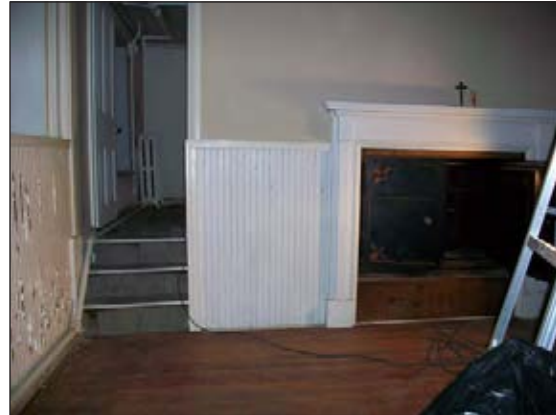
Figure 8: Room 102 showing safe-filled fireplace and stairs into Room 103, 2010.

102: The central room on the first floor contains a closet in the southeast corner which conceals the location of the door opening that is expressed on the exterior of the south elevation. The south wall has two six-over-six double-hung sash windows. The north wall contains one six-over-six double-hung sash window and built-in shelving. The west wall has the remnants of a fireplace that has been converted into a recess for a safe. The ceiling height in this room is 8' 10".

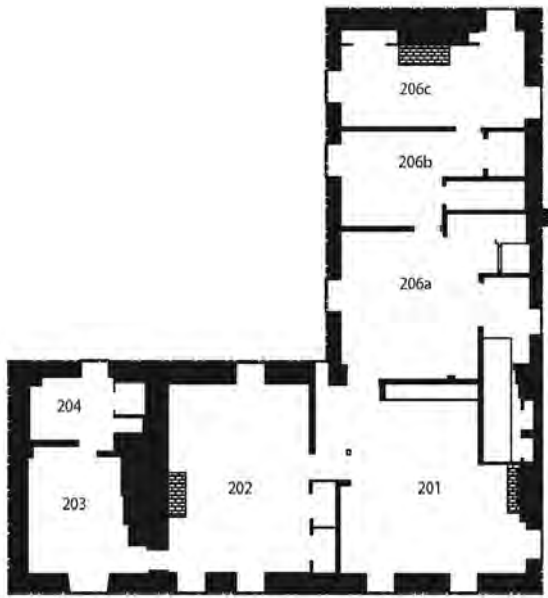
*Figure 9 Second floor plan, 2010.*

The second floor contains five rooms and one bathroom. Oak strip flooring covered all of the floors; however, most of it has been removed. Most doors on the second floor appear to date to the early-19th century and feature raised panels set in stiles and rails that are joined with mortise and tenon joints. Rooms 201 and 202 have simple baseboards about 6" in height and chair rails 2' 6" above the floor.

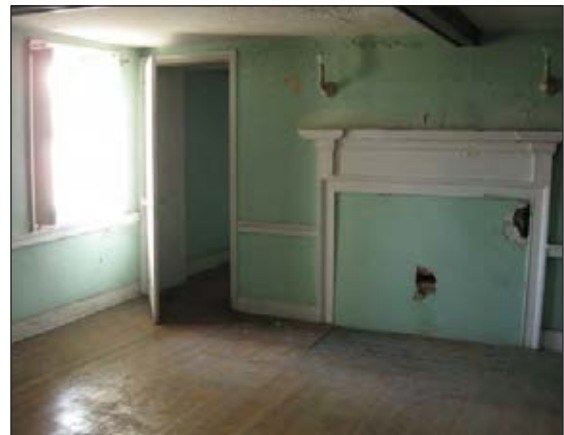
*Figure 11 Room 202, southwest corner, 2010.*

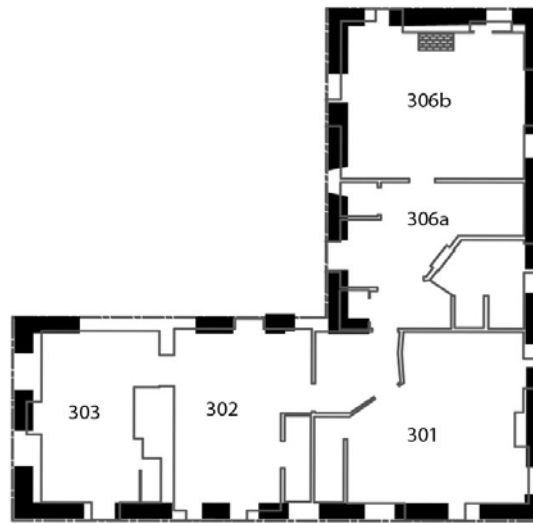
*Figure 12 Third floor plan, 2010.*

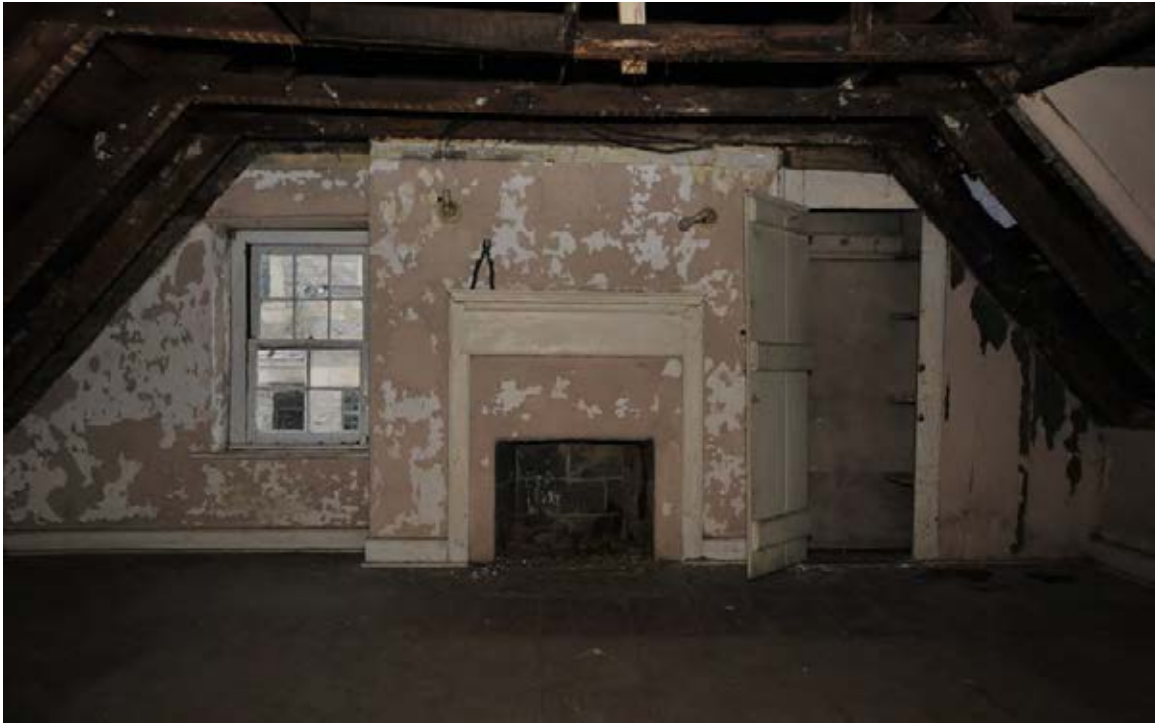
*Figure 13 Room 306b, north wall, 2010.*

306b: The north end of the attic consists of one large room, which had nearly all of its wall and ceiling plaster removed, revealing the framing members. There is a fireplace in the north wall with a very small, simple mantle, as well as a four-over-four double-hung sash window and a small, shallow closet with a board and batten door. The east wall has a dormer window with one window opening and the west wall has a dormer with two window openings. The floor is composed of wide random-width floorboards that appear to be original.

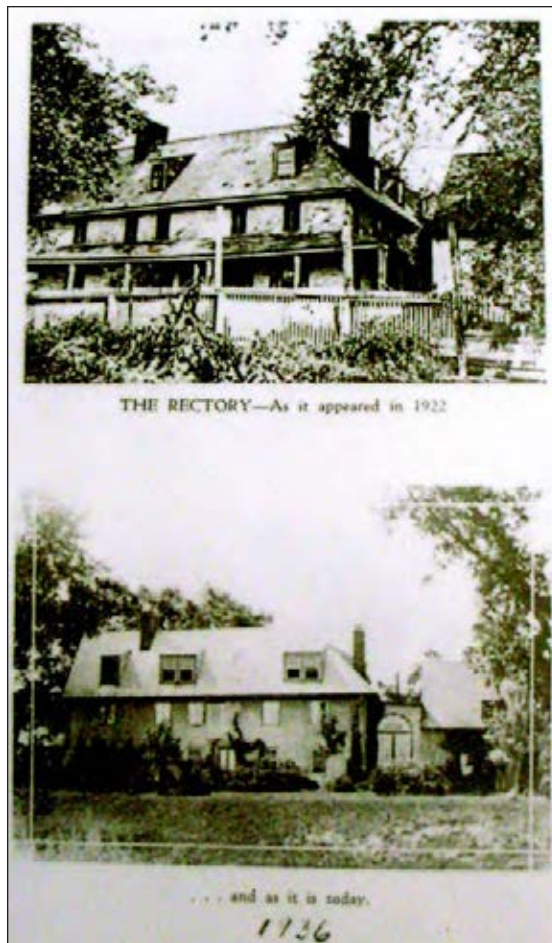
**Figure 6** *Changes in Sellers Hall during St. Alice's occupation.*

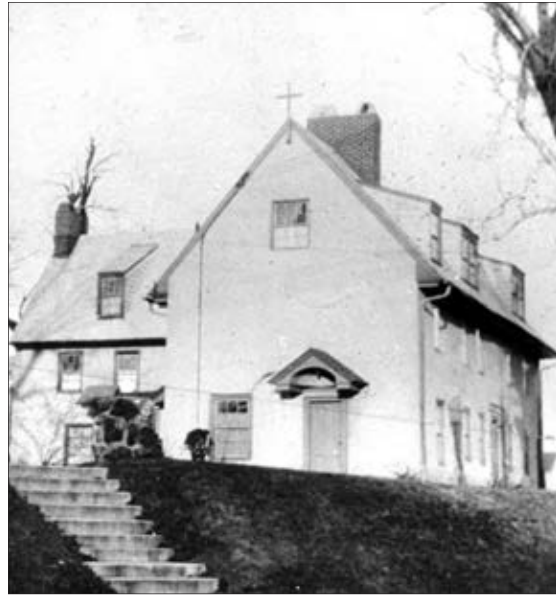
*Figure 2 West end of Sellers Hall in the 1930s showing the west addition seamlessly blended with the rest of Sellers Hall with a layer of stucco.*

The building was significantly altered during St. Alice's ownership. On the interior, the framing of the first floor (except in the western addition) was lowered by 2' in the 1920s and first floor fireplaces were altered to match the new floor height. When Saint Alice's acquired the building in 1922, the structure may still have had a 19th century wrap-around porch and surrounding fencing. Sometime in the 1920s a frame link structure was built between the east wall of the house and the detached kitchen. It had horizontal wood siding, a window and door on its first floor and double windows on its second story. (Fig. 1). By 1934, the fence and porch had been removed, a few dormers on the south and east façades had been widened by an additional window. Also, the façade was given a uniform look with stucco, and the frame passageway was altered with the addition of a two-story arched window. A 1930s photograph of the home and detached kitchen seems to reflect a period between these changes (Fig. 2). The porch is gone, but the dormer windows have not been widened and the second story of the east façade is exposed stone

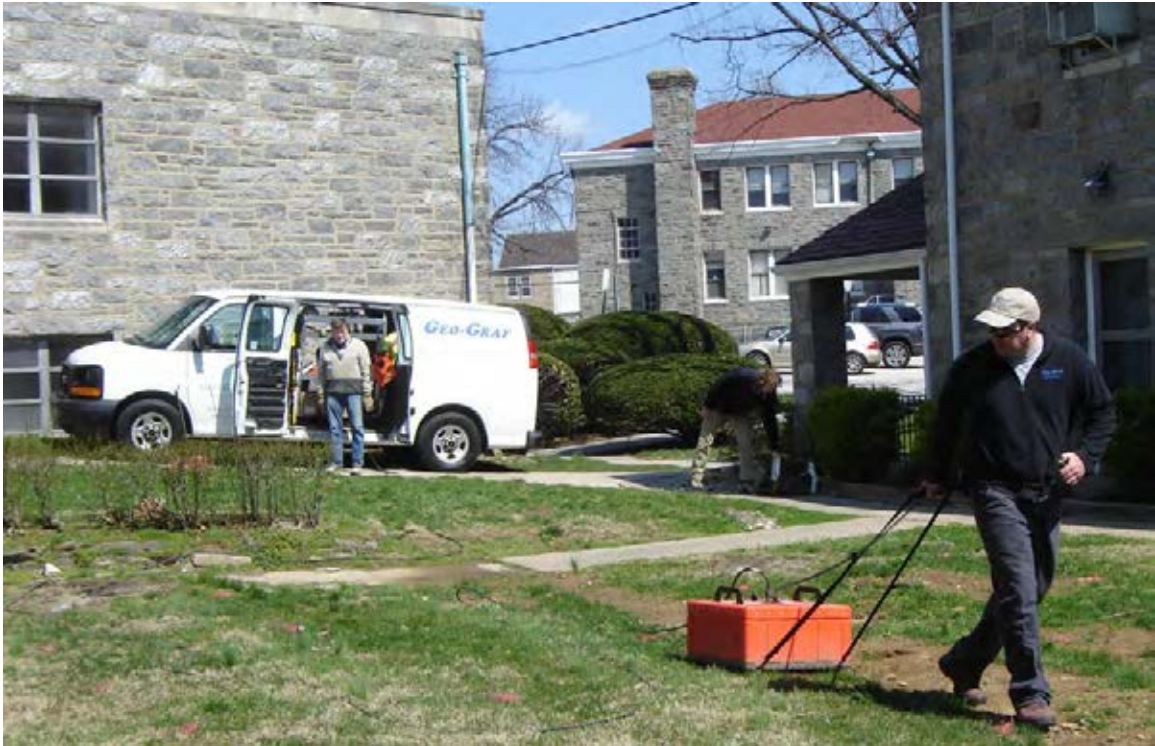
*Figure 1 Mr. Graf, from Geo-Graf Incorporated, conducting the Ground Penetrating Radar.*

GPR profiles were completed at 2½’ intervals in both the north-south and east-west grid directions in an attempt to delineate subsurface anomalies. The GPR data was collected using two different frequency antenna systems: a 400 MHz and a 200 MHz system. The data profiles were recorded for review and post-processing at the GGI office. Possible anomaly locations observed from the field data were field-marked and documented. A total of 39 GPR data profiles were recorded for this project.

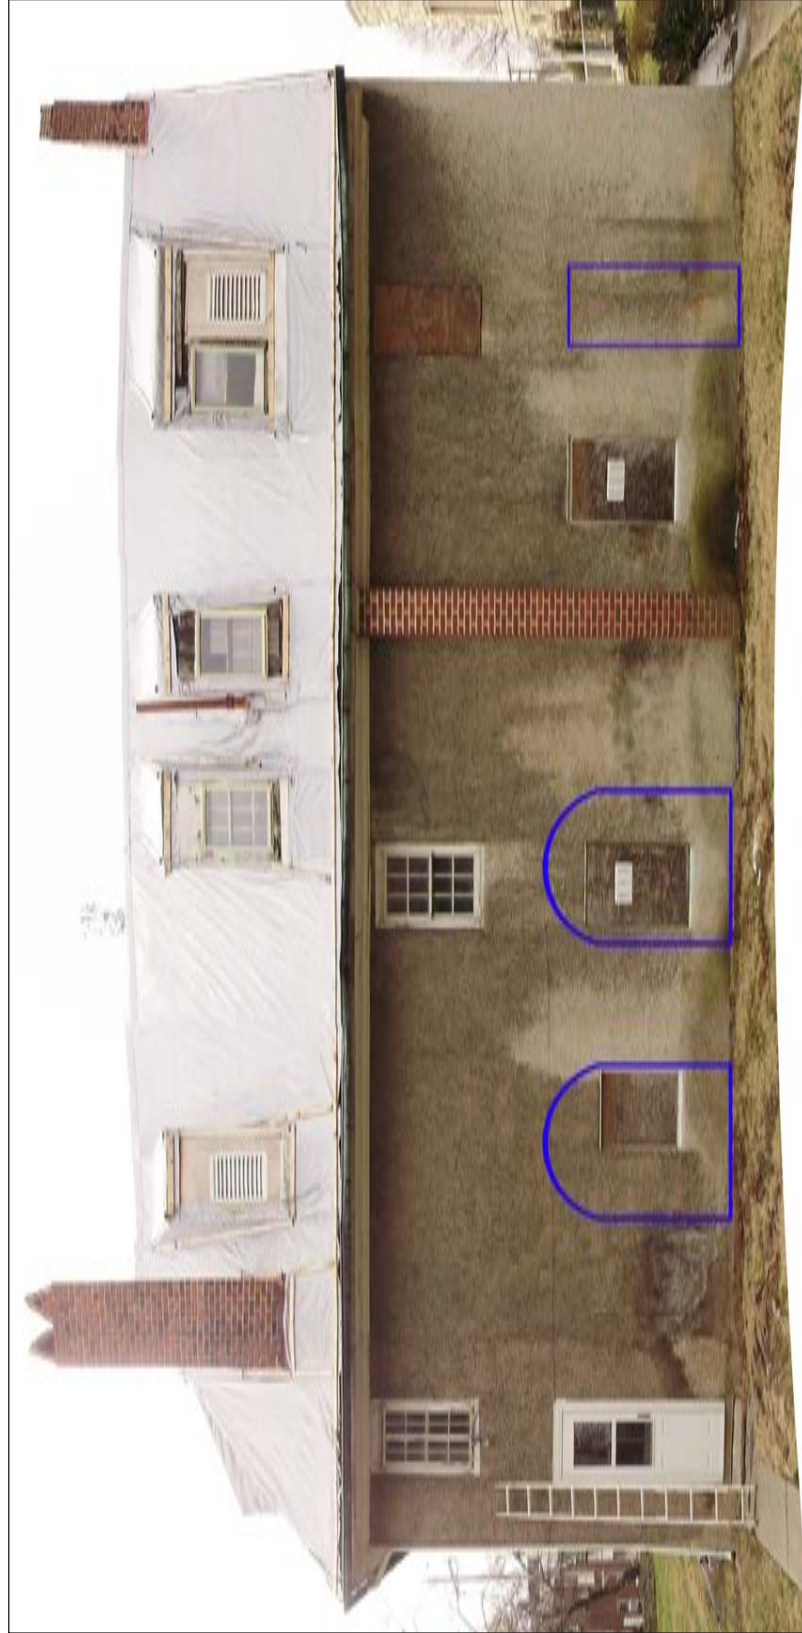
**Figure 4** This image of the eastern façade, displays two brick arches and one filled in doorway. The first arch from the left could have served as a doorway leading from Sellers Hall to a breezeway, however its low apex makes this assumption problematic. The second arch from the left is also above a window and could have been included to support the weight of the wall when the window was installed. Finally, a filled in doorway was discovered on the northern end of the eastern façade. This entrance could have allowed for passage from Sellers Hall into an outbuilding that butted against Sellers Hall and the breezeway.

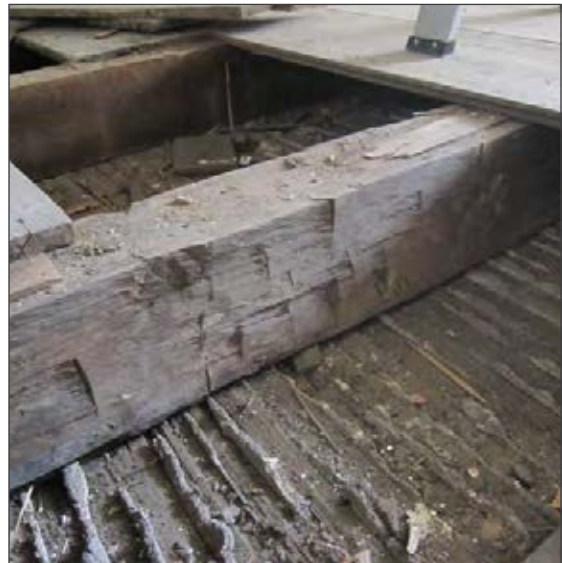
*Figure 1 Hand hewn joist room 302, 2010.*

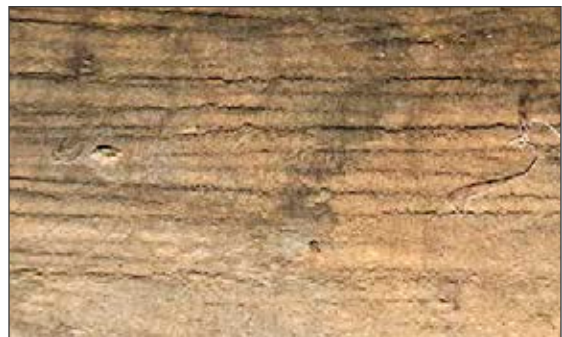
*Figure 2 Pit saw marks, 2010.*

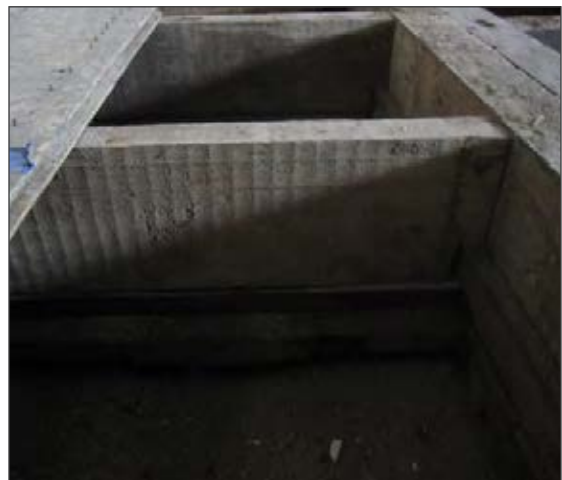
*Figure 3 Vertical sawmill marks, 2010.*

Eventually the sawmill replaced human labor, but the system configuration changes were barely perceptible. The log was still supported as if over a pit while a system of cranks and pulleys replaced the men. The undershot wheel served as the driving force for the sawmill, operating a pitman that drove the saw frame up and down. The carriage advance that moves the timber had to be overseen by the sawyer, keeping him an integral part of the process. Lumber produced at a sawmill had consistently parallel vertical marks and was used extensively in Sellers Hall in both the floor and roof framing dating from the early-19th century (**Fig. 3**).

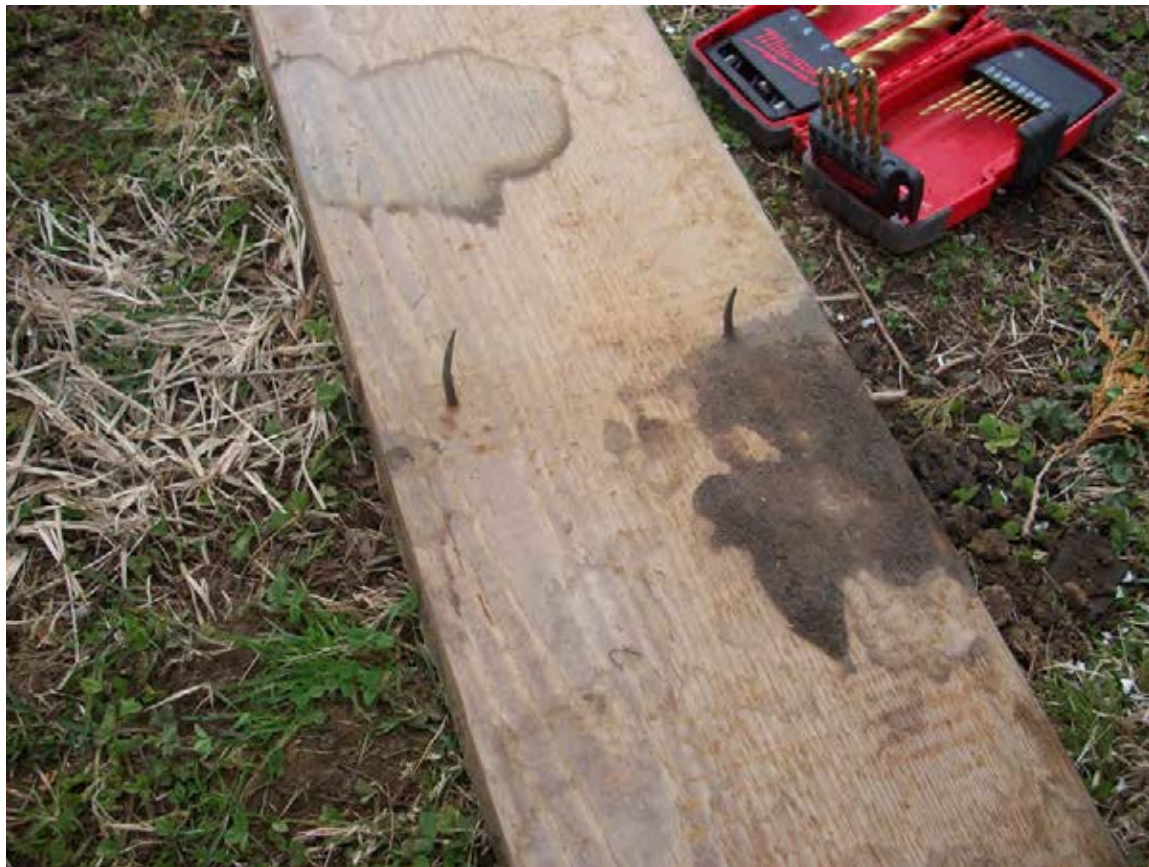
*Figure 8* The interior side of the soffit board after removal. The wood is hand planed and the nails are hand wrought.

The boards of the soffit were removed and examined thoroughly. The boards were pit-sawn, with only one campaign of hand-wrought nails. The saw marks and nails are evidence that this is the original cornice of Sellers Hall. When the building was later expanded, a new cornice was added as an addition on each side, wrapping the house. This allowed the original cornice of Sellers Hall to be preserved for centuries, performing the originally intended utilitarian and decorative uses.

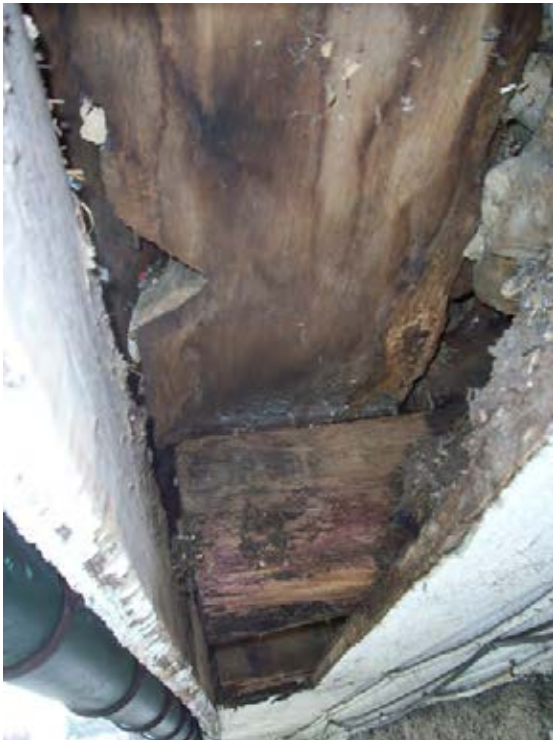
**Figures 10 & 11** Images of the original cornice. The stone of the knee wall can be seen through gaps and notches in the board.

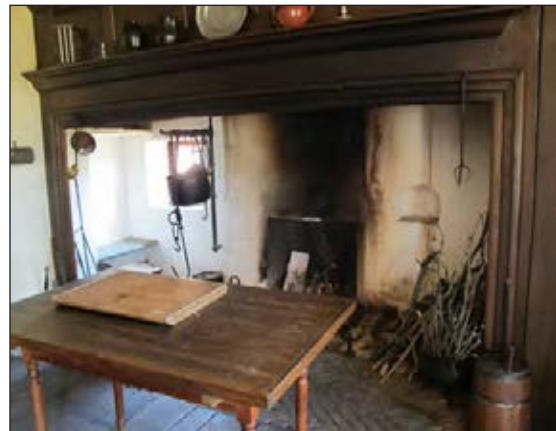
*Figure 1 The fireplace from the Barns-Brinton House.*

Thomas Massey House, Varnum's Quarters, and the Barns-Brinton House (**Fig. 1**). These fireplaces were large enough to walk into, and some contained a window and were flanked by a winding staircase (John Chad House, Varnum's Quarters and the Barns-Brinton House). The chimney at the fireplace of the typical Delaware Valley house was contained internally in the structure, unlike early homes in Virginia that

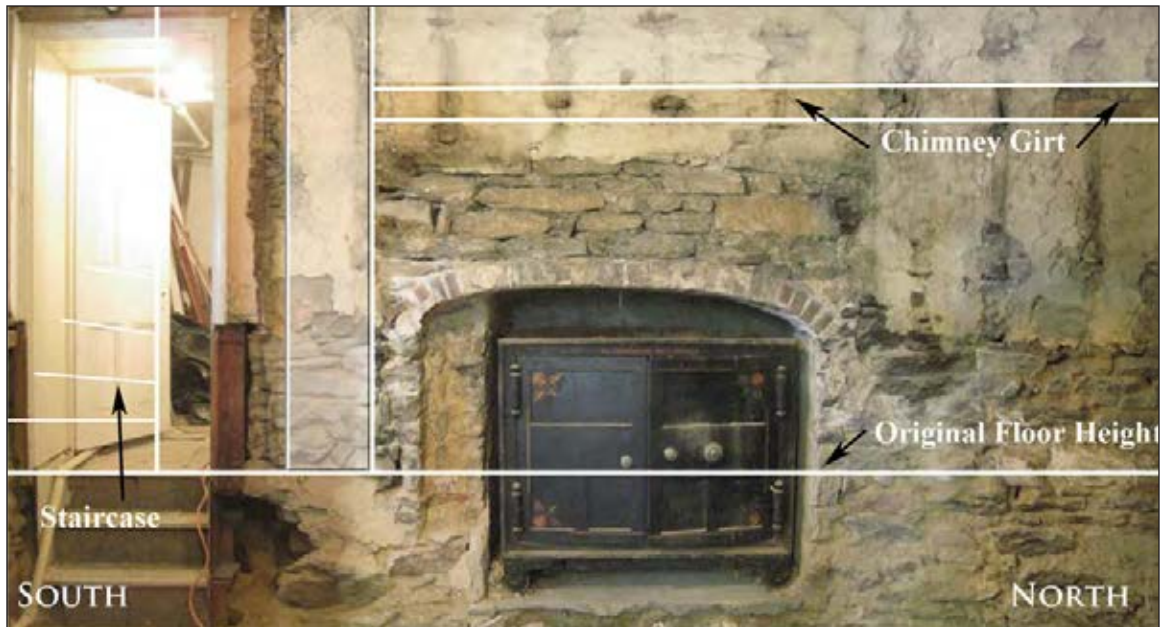
**Figure 2** This image shows where the cooking fireplace would have been positioned in 1680. The extant wall would have been the back of the stairwell and the fireplace and the structures would have extended approximately 4 ft into the room.

At Sellers Hall, a large cooking fireplace with a bake oven was located in the north-west corner of room 102. A large stone in the ground beneath room 103 may be the extant foundation of the bake oven. It would indicate that the oven was centered in the room but in the south corner of the cooking fireplace (**Fig. 2**). A winding staircase was located south of the fireplace. The first indication that the west wall had been the location of the cooking fireplace was the discovery of a wide pathway of black and greasy soot in the attic on the east side of the gable end wall. This indicated that an earlier flue or chimney mass associated with a wide cooking fireplace extended east from the chimney's current location. The flues of the second floor fireplace and cooking fireplace converged on the third floor.

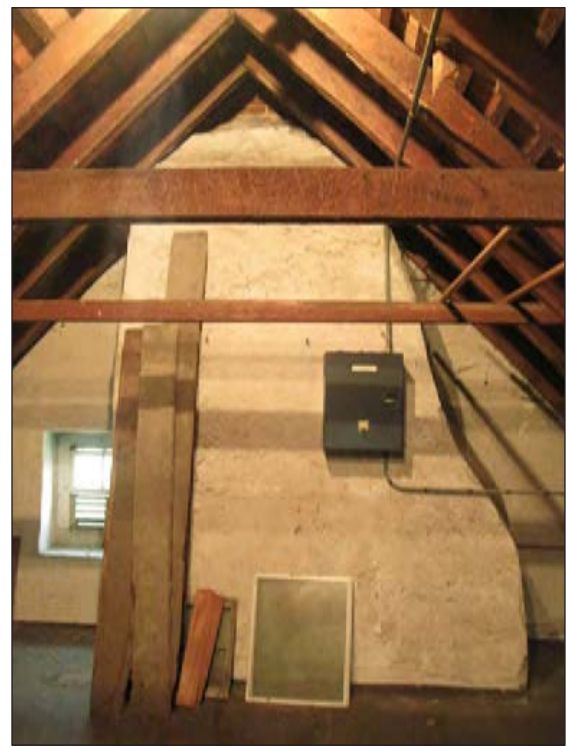
**Figure 3** The chimney at Varnum's Quarters, visible on the third floor.

nificant space in the room, as in the third floor of Varnum's Quarters (**Fig. 3**)

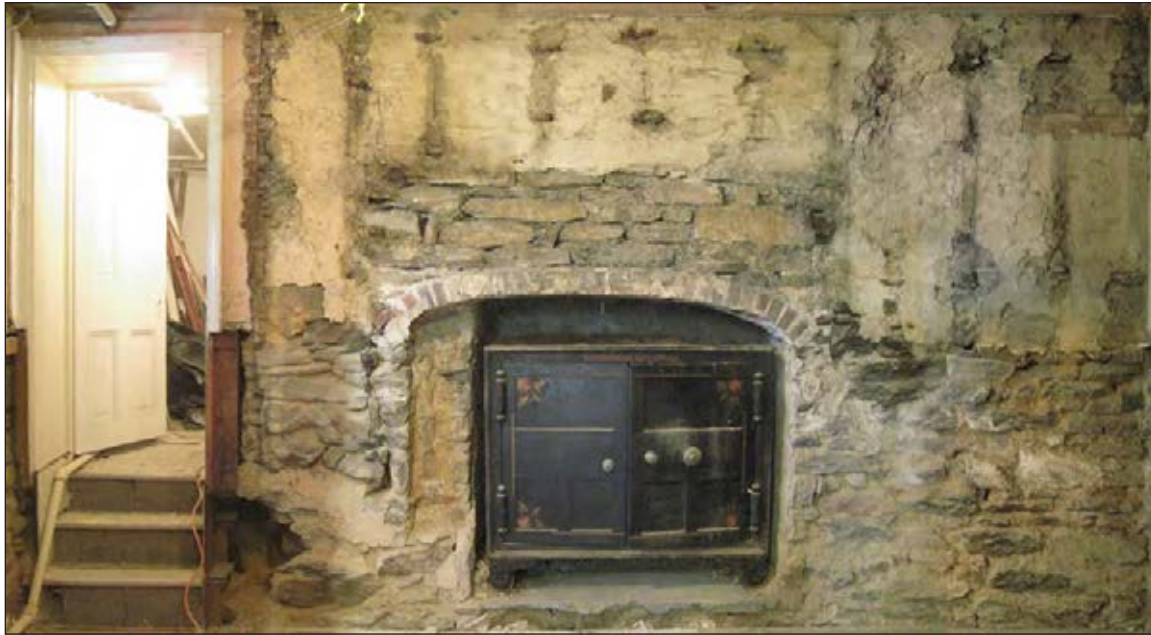
*Figure 4* Elevation of west wall, in Rm 102. The brick arch of the firebox and north cove can still be seen.

At the time, the fireplace was transformed by the addition of coves (Fig. 4). These were created by filling corners with small stones and mortar, which were then covered with plaster to present a smooth, curved appearance. The brick arch of the firebox opening and the north cove of the fireplace remain from this building campaign. The design of the fireplace, the horsehair plaster remaining on the cove, and the nails used in the hand-hewn lath are characteristic of the early 1700s. If there was a mantel at this time, it may have been similar to the parlor fireplace in the John Chad House (Fig. 5).

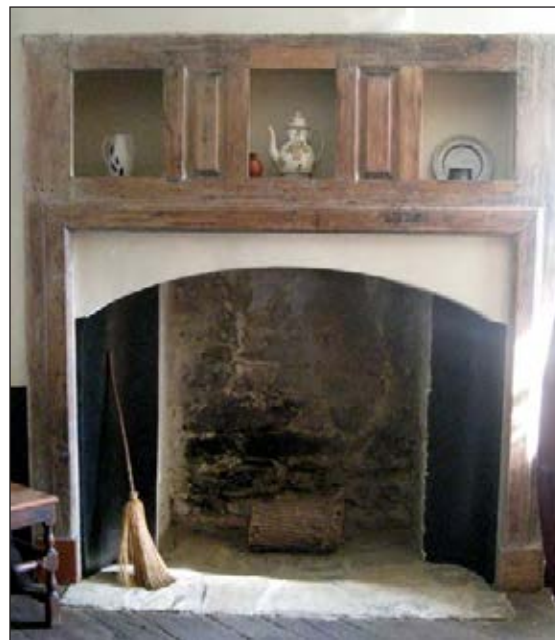
*Figure 5* Parlor fireplace at the John Chad House. This may have been similar to the original fireplaces in the east end of the house.

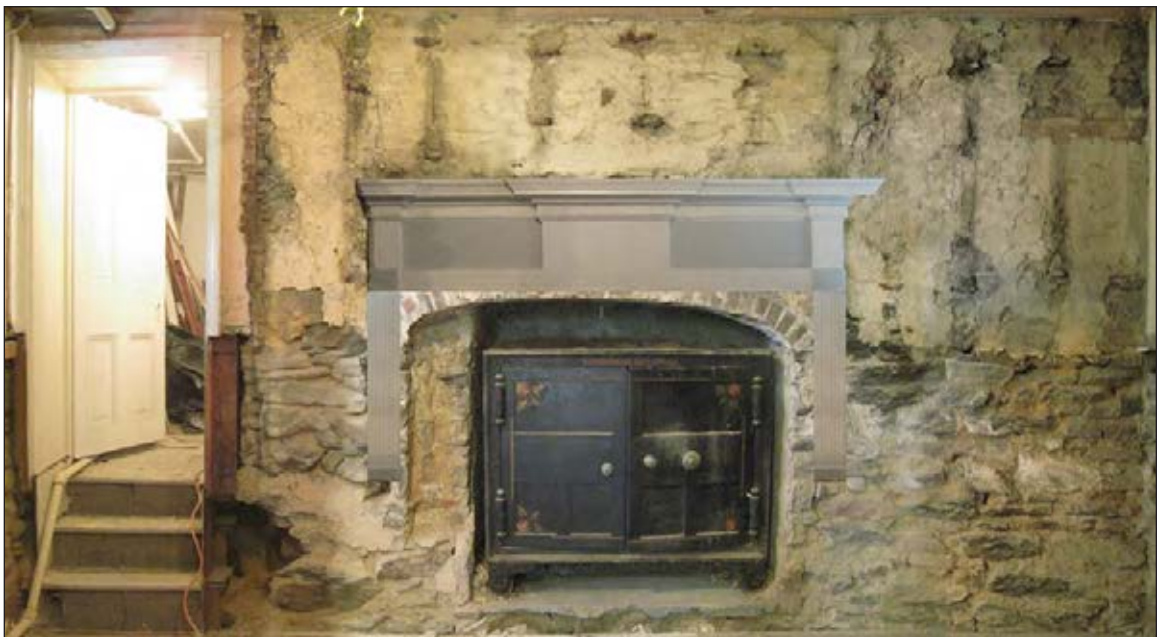
**Figure 6** Image of the mantel with leg height at the original floor level using the molding profile of the first floor east fireplace which resembles the mantel in the photograph.

A heating stove was placed in the room and vented through the fireplace's chimney, which can be seen in a historic photograph of Sellers Hall. The ghost of the Federal-style mantel profile from this period can still be seen in the plaster on the wall. A conjectural image of what that fireplace and mantel looked like is below (**Fig. 6**).

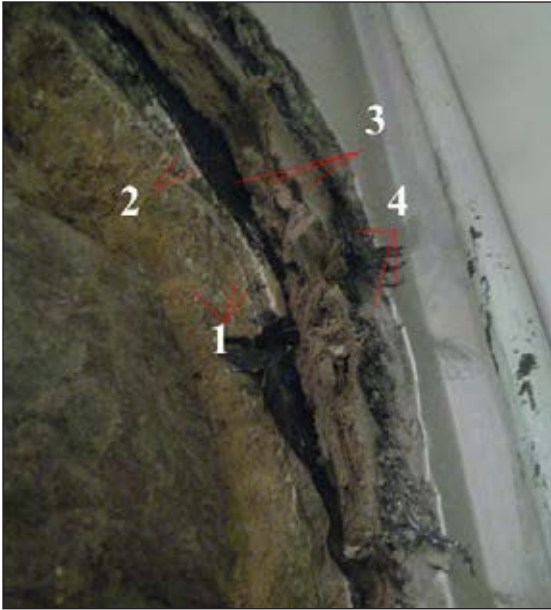
**Figure 7** The stratigraphies of finishes on the fireplace in room 106: substrate: schist; layer one: brown coat, scratch coat and finish coat of plaster; layer two: scratch coat and finish coat of plaster; layer three: vegetable board, fiber board and plaster; layer four metal lath, scratch coat and finish coat of plaster.

A similar structural change was made to the other fireplace on the first floor in room 106. Like the fireplace on the east wall, this fireplace was added when the northern addition was constructed in the early 1800s. The mantel can be dated to the time through nails and molding profiles, (See *Appendix A: Analysis of Finishes from Sellers Hall*). When the floor was dropped, a brick firebox was also inserted underneath this mantel and posts and plasterboard behind, causing it to lose its legs and be pushed out into the room from the wall. Though these two first-floor fireplaces have been truncated, there is still enough evidence to create an image of what they would have originally looked like (**Fig. 7**).

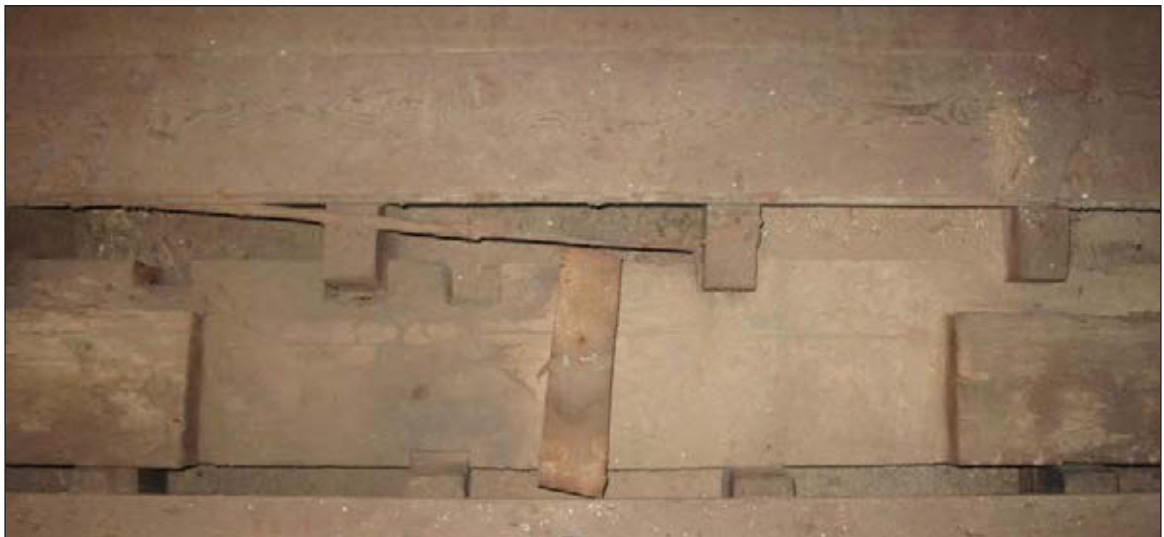
**Figure 8** The notch cut into the summer beam indicates the original placement of the hearth in the room.

the second floor (room 202). The original second-floor fireplace was a parlor fireplace with paneling extending to the ceiling. Indeed, the outline of its hearth is visible through cuts into the supporting summer beam (**Fig. 8**). There is also evidence on a third floor joist. The beams that supported the third floor were originally exposed on the second floor ceiling. When the fireplace wall was plastered, some of the whitewash spread to the wood beam and is still visible (**Fig. 9**).

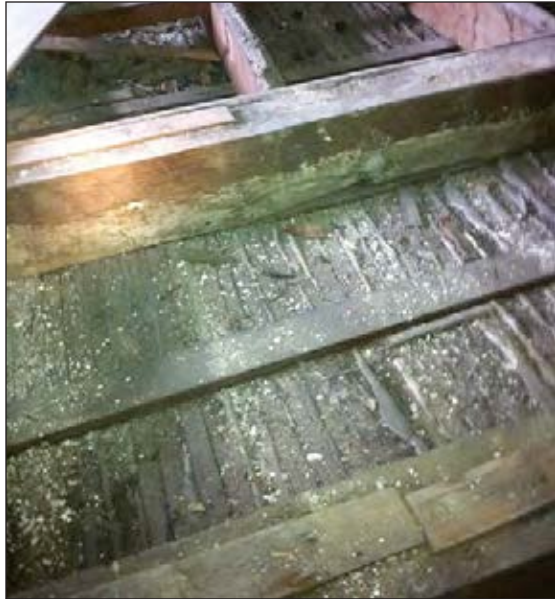
**Figure 9** White wash on the underside of a beam on the third floor showing where the fireplace on the floor underneath would have been.

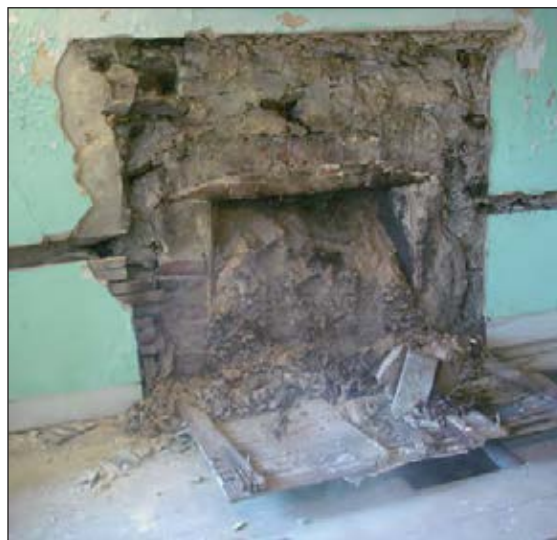
**Figure 11** Image of the interior of the fireplace once the plaster and lath was removed.

In 2011, the plaster and lath covering were removed from the wall, revealing the fireboxes, arch, and infill; it also revealed a significant amount of debris that had fallen down the chimney. This was dug out with shovels and dust masks, though much debris remains compacted in the flue (**Fig. 11**).

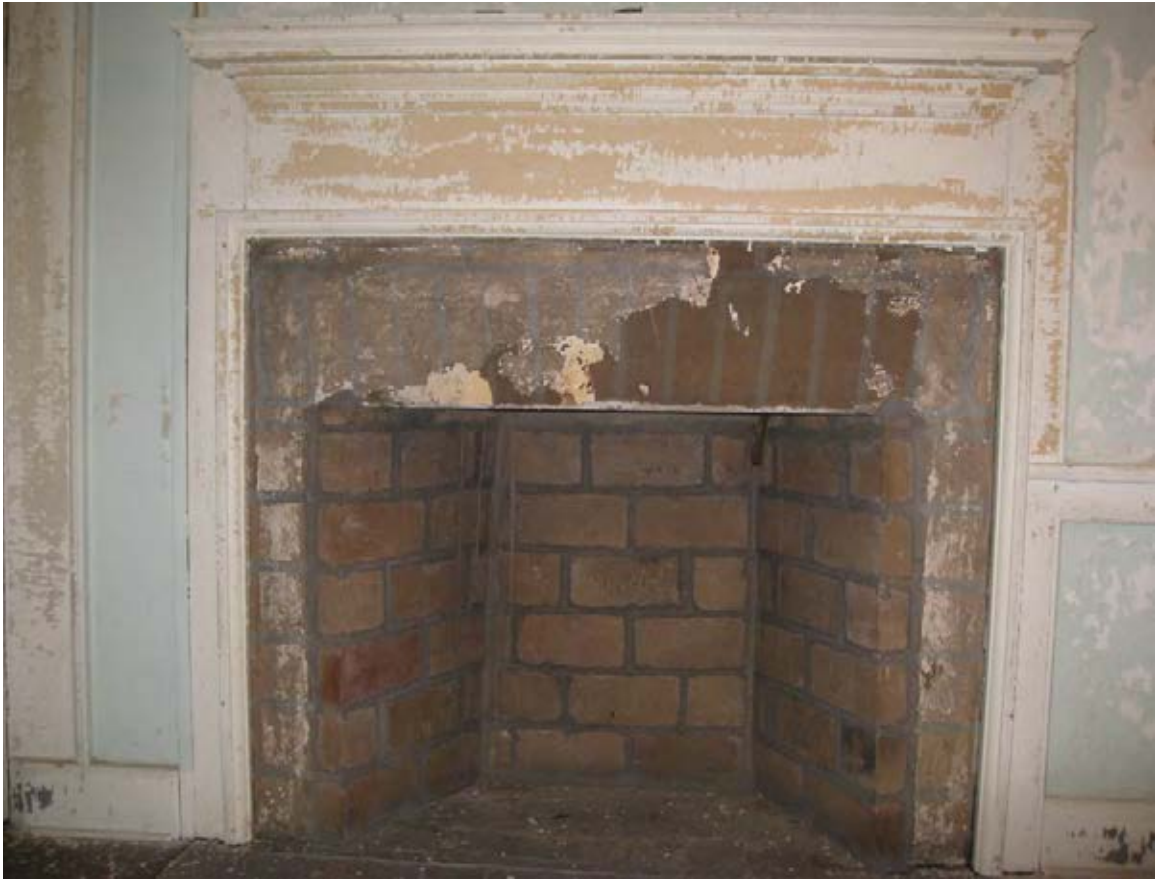
*Figure 12 Image of a fireplace highlighting the multiple campaigns of faux-brick finish.*

Room 206c contains the other fireplace on the second floor. The moldings and placement with the plaster are consistent with early 1800s construction. The moldings are less ornate than those on the first floor or other second floor rooms, suggesting that this part of the house was for more private use. The firebox's brick surround had multiple layers of finishes applied, including two paint campaigns that painted the brick to look like brick. It is not blackened, so is probably not original (though it may have been cleaned). The bricks of the firebox also tilt slightly to point into the room, which is uncharacteristic in Federal-style ornament. The bricks have a large manufacturer stamp on them that says "Minor" which stands for the Minor Fire Brick Company that operated in Ohio in the 1890s (**Fig. 12**).<sup>8</sup>

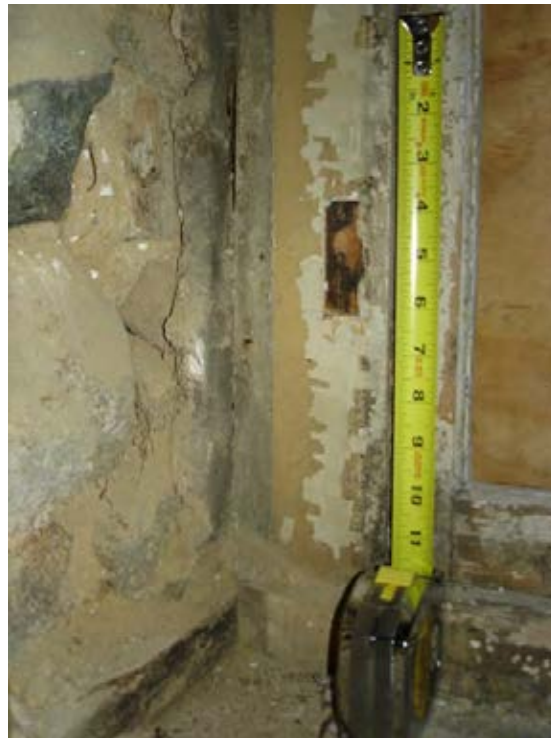
Figure 3 Photograph of window NID detail.

In the closet located in room 303, a small opening in the masonry approximately 5' from the finished floor was discovered beneath the current-day plaster. The western side of the opening measures 15" x 15" with sides and header splayed approximately 4" beyond these measurements toward room 302, indicating that the opening dates prior to the construction of room 303. Part of the wooden frame remains in place with a leather strap hinge attached with a hand forged nail. This yields information about its original function and configuration of the opening. Rounded indentations, in mortar that the frame was seated in, indicate that the window probably had bars or louvers instead of glass and that it was used

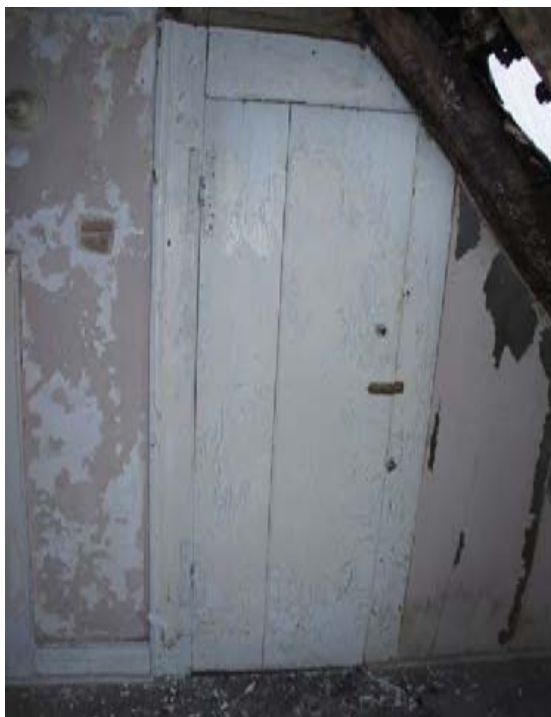
**Figure 7** Photograph of late 17th-/early-18th century, plain and batten door.

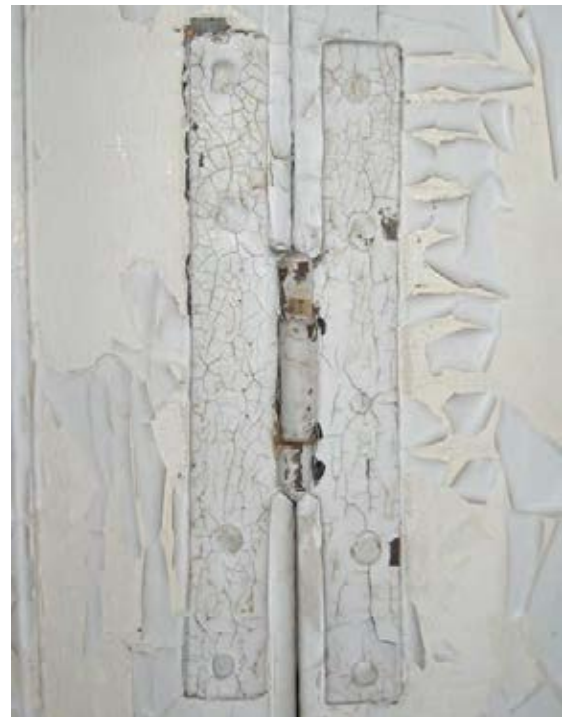
**Figure 8** Photograph of H-hinge, popular during the 18th century.

A plain and batten door in room 306b is perhaps the oldest door in the building. This door type can be dated to the late-17th/early-18th century (**Fig. 7**). The wrought-iron H-hinge connected to the door was also popular during the 18th century (**Fig. 8**).<sup>9</sup>

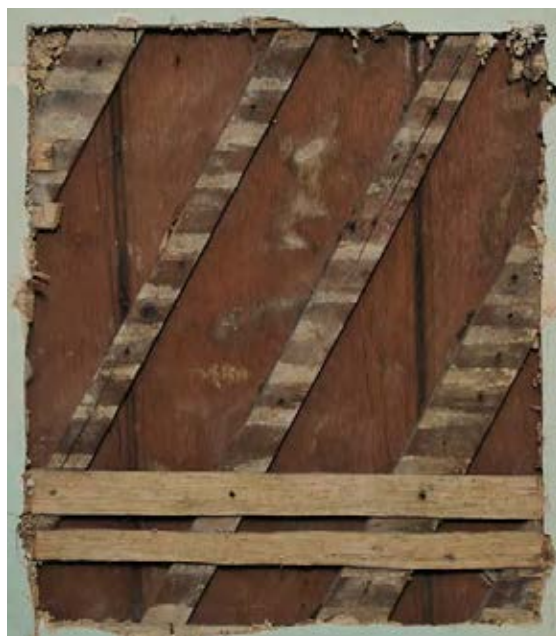
*Figure 1* Wood Board Partitions from the East, 2010.

a bead on the edge of each board. Initially thought to be connected with a spline joint, where each opposing board accepts a thin sliver of wood called a spline, upon further inspection from the third floor, it was determined that they were tongue and groove. In a tongue and groove joint, one board has a tongue, which is accepted into the groove in the adjacent board. Over the years, the western side of the board partition has remained exposed, and as a result, has experienced many different paint campaigns, which made it difficult to ascertain the materials and finish. Once the board partition was discovered in the rear of the closet, the decision was made to begin removal of the plaster on a small portion of the eastern side of the partition to further explore its condition and materiality. Initial plaster removal revealed a plaster light in color, mixed with blond and ginger colored horsehair which is a sign of a very early (possibly 18th cen-

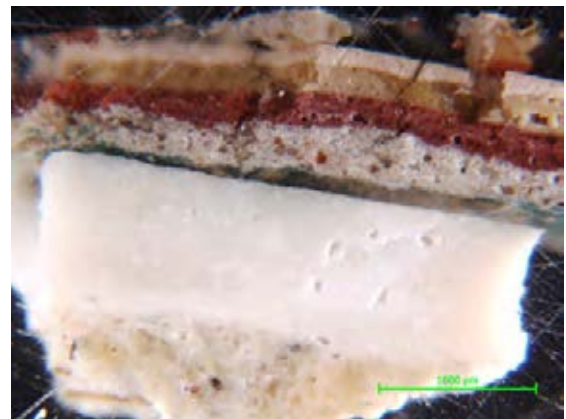
*Figure 1* Sample from plaster on first floor, 2010.
