# *Sellers Hall*

## Upper Darby, Pennsylvania

A report compiling the archival and architectural research of Sellers Hall, from the spring terms of 2010 and 2011. Prepared by the Architectural Archaeology Class of the Graduate Program in Historic Preservation—School of Design, The University of Pennsylvania.

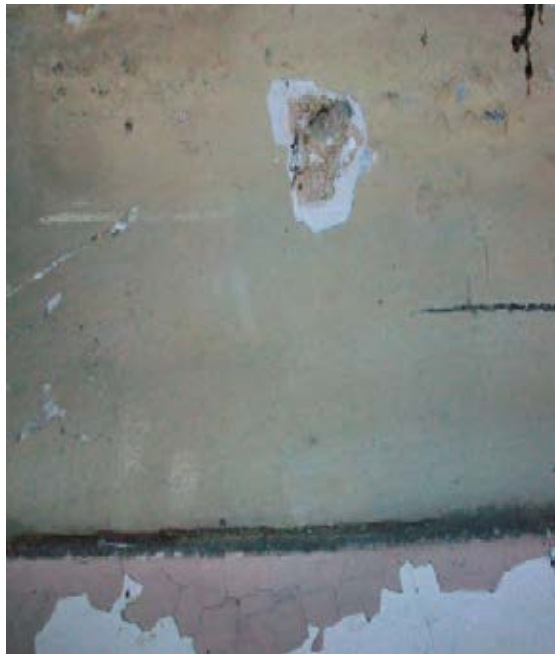
*Figure 6* Crater above ceiling line, 2010.

posed of a large amount of mica particles that are visible to the naked eye in areas where the paint has flaked off; it can be revealed manually with little effort. The ceiling was lowered upon the installation of the pressed tin ceiling sometime in the early-20th century. Sample 13, taken from above that ceiling line, is helpful for approximately dating the campaigns, (See *Appendix A: Analysis of Finishes from Sellers Hall*). Sample 13 shows several layers of white paint interrupted midway by a thick layer of reddish brown. Above the white, there is a layer of yellow with a dirt layer in the middle.

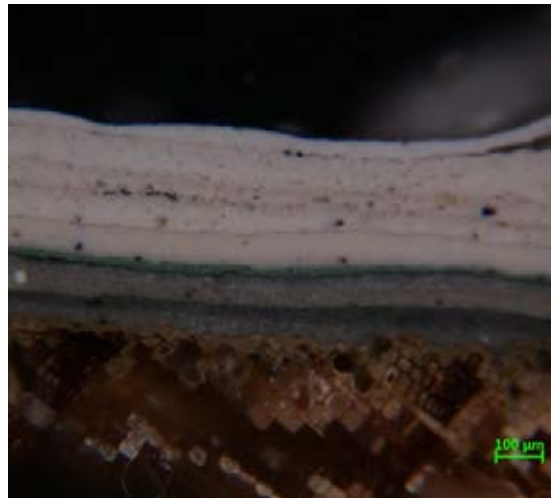
*Figure 7* Sample from exterior window on north facade, 2010. layer following the yellow paint campaign.

Samples taken from the walls surrounding the room's windows show a similar stratigraphy. The double gable on the eastern wall was added between 1922 and 1934. The original color of this section was white. Later layers show the same progression from white to mint green to pink as the wall stratigraphy. A sample taken from one wall surrounding the original windows to the west of the fireplace shows that it was painted in the same series of campaigns as the rest of the walls; however, there is a sizable dirt

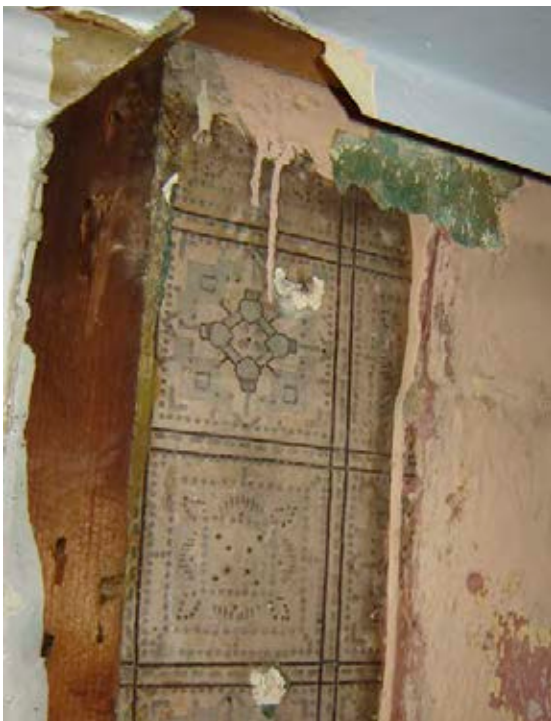
**Figure 8** Photograph of historic wallpaper patch in the southern wall.

Wallpaper analysis allows us to understand what the interior of Sellers Hall might have looked like long before the first photographs were taken. This analysis was inspired by the discovery of a small patch of well-preserved wallpaper still clinging to the southern wall of the house, in room 101 (**Fig. 9**). Although initial attempts at procuring a small sample of this wallpaper fragment were unsuccessful, another piece of the same paper was found behind some plaster several feet to the left of the fragment. Although early French and American wallpapers are difficult to date, this wood block printed, linen paper most likely dates from the 1830s to the 1850s.

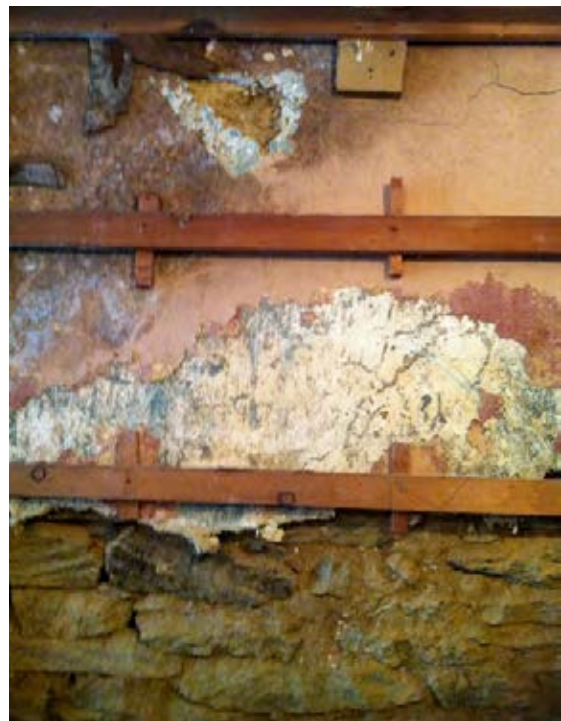
**Figure 9** Photograph of historic wallpaper.

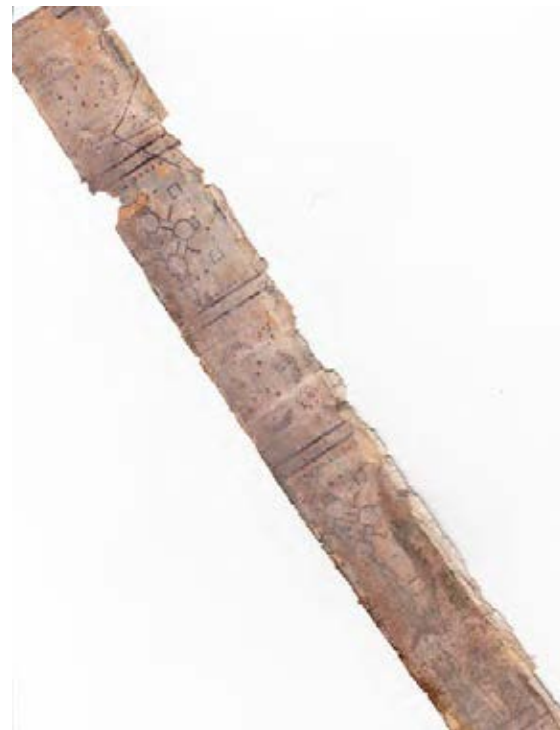
**Figure 11** Rag paper (handmade), hand stenciled, American or a French import acquired in Philadelphia, 1750-1830, room 101.

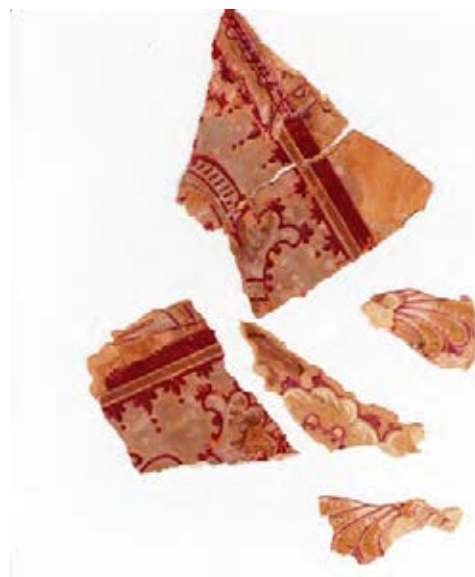
**Figure 12** Wood pulp paper (machine made), machine printed, American, 1840-1870, found under the stairs in room 206A.

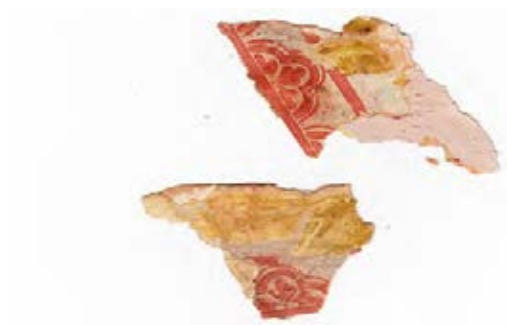
**Figure 13** Wood pulp paper (machine made), machine printed, American, 1840-1890, room 201.

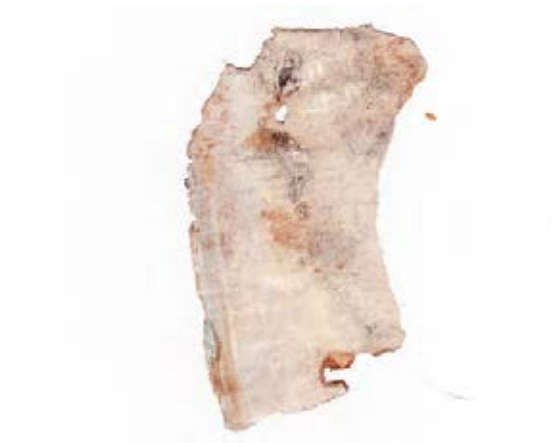
**Figure 14** Wood pulp paper (machine made), machine printed, American, 1880-1940, ceiling paper, room 206A.

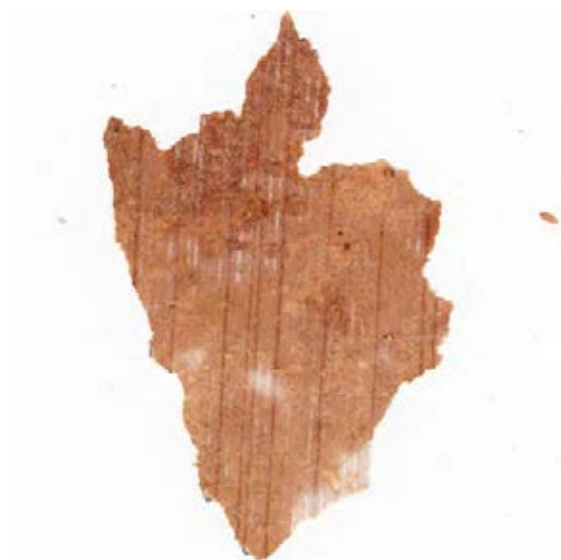
**Figure 15** Wood pulp paper (machine made), machine printed, American, 19th century, eastern wall of room 206A, above stairwell.

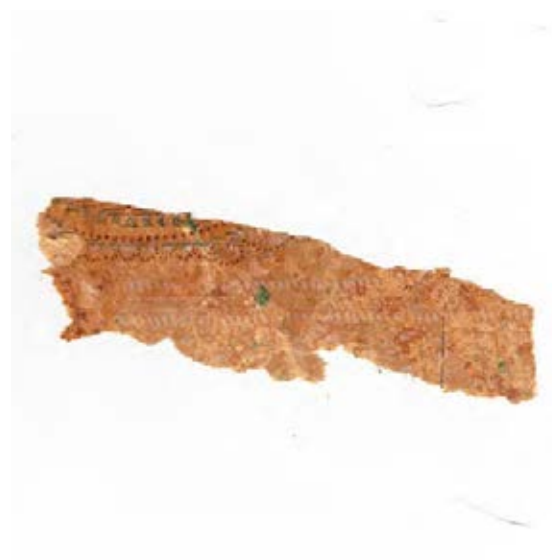
**Figure 16** Wood pulp paper, block printed, American, found behind oatmeal paper in room 201.

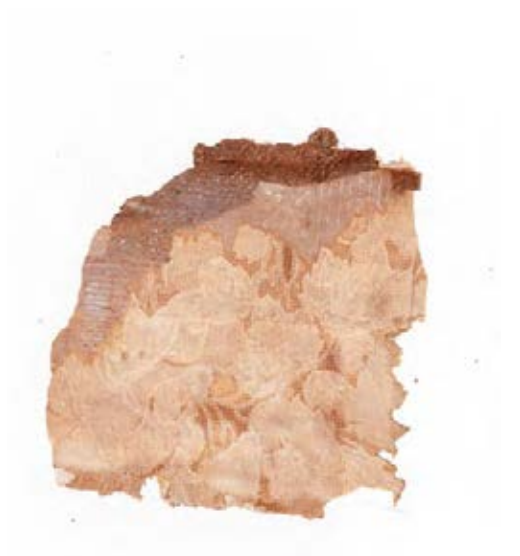
**Figure 17** Rag paper (handmade), block printed, American/French, 1820-1850, found behind the oatmeal paper in room 202.

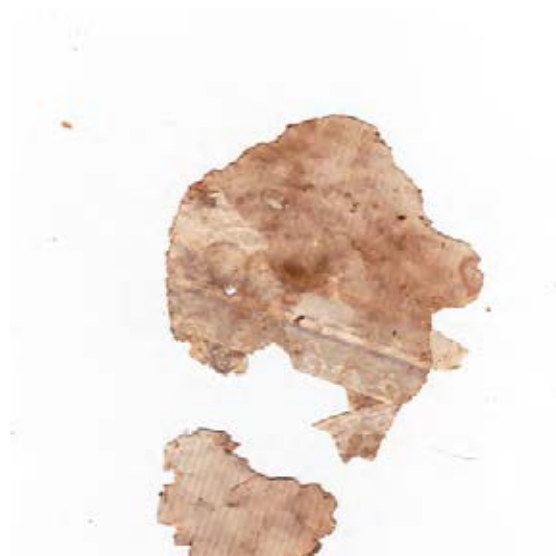
**Figure 19** Rag paper (handmade), block printed, American, 1840-1870, found near the fireplace in room 202.

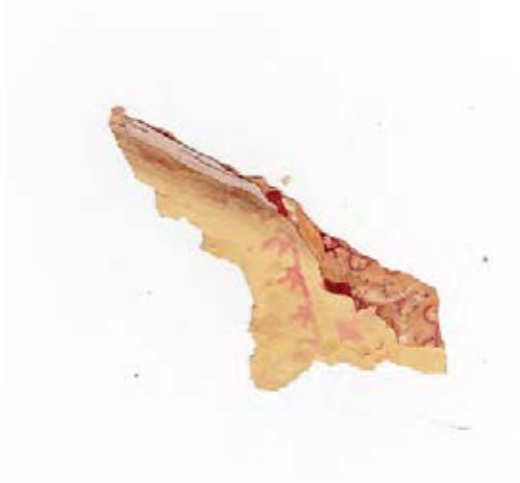
**Figure 18** Wood pulp paper, block printed, American, 1820-1840, found stuck to Sample #2 in room 206A.

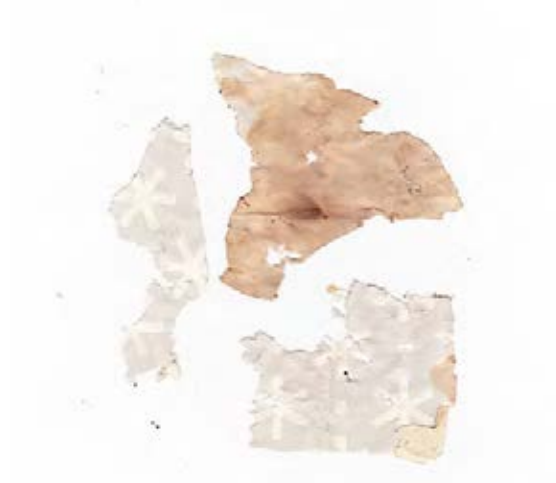
**Figure 20** Rag paper (handmade), block printed, American, 1800-1860, room 204.

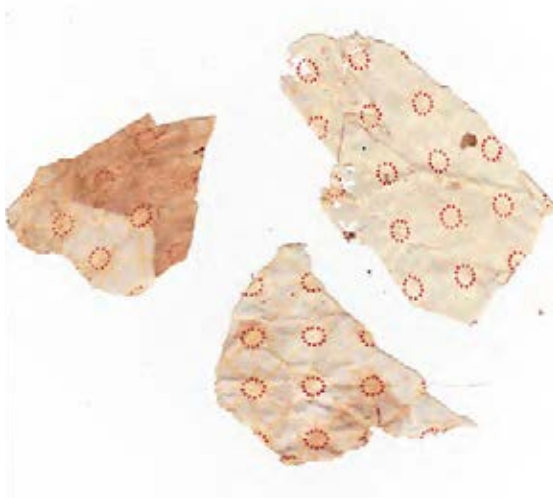
**Figure 21** Rag paper (handmade), block printed, American, 1800-1860, room 104.

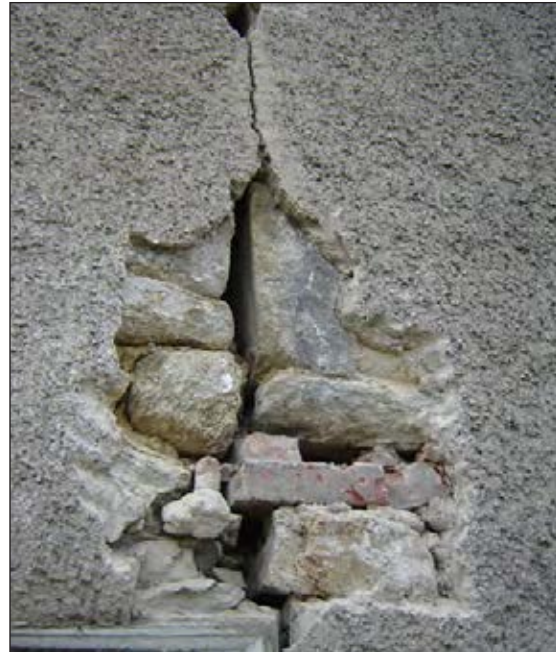
*Figure 1 Northwest corner of building A – pointing continues around the old corner from the west wall to what was the north wall of building A.*

current west wall remains in the exterior stonework. A settlement crack in the stucco of the west wall, which runs upward from a first floor window, delineates the northwest corner of building A. The crack was cleared of stucco using a power chipping hammer to reveal that pointing continues from the west wall into the crack to the former north wall. This pointing once continued across the north wall of building A (**Fig. 1**).

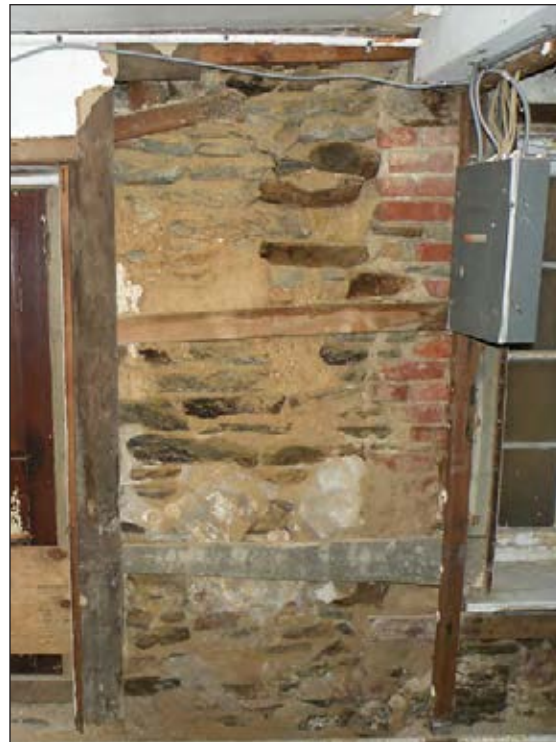
*Figure 2 "A vertical patch of bricks in the 1st floor west wall of the west addition shows where the north wall of building A was removed."*

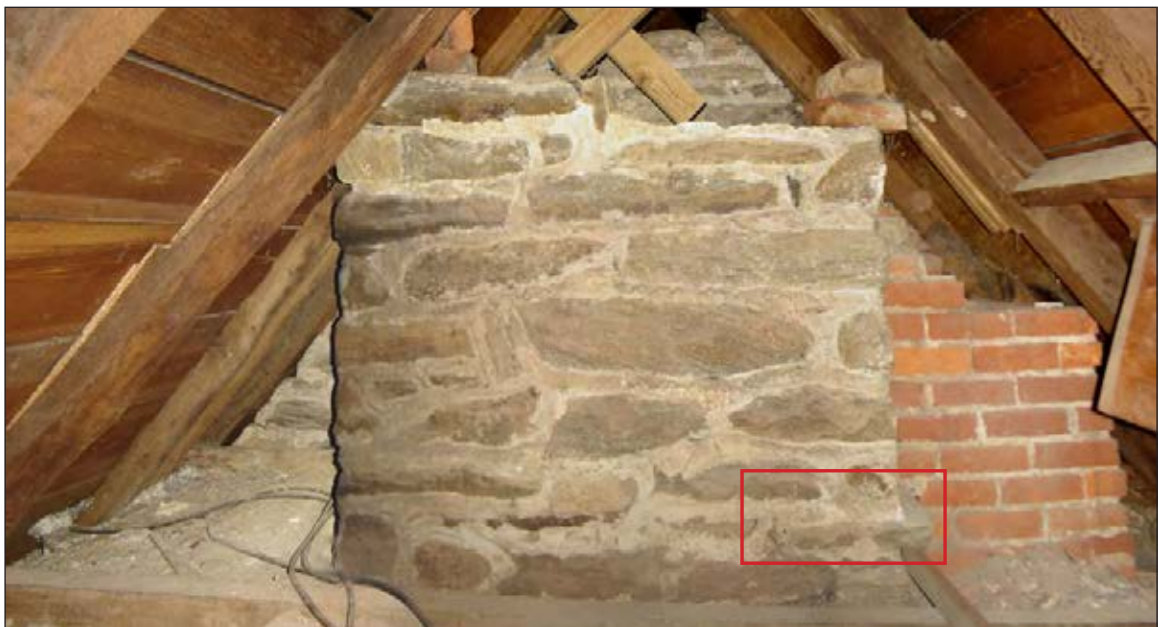
**Figure 3** “The stack of the west chimney features a projecting flat stone at the lower right side of the stone work. This was a flashing course to shed water away from a former roof for building A that abutted the chimney”

The roof for building A was likely built up to a stone flashing course that was discovered in the current attic space on the south face of the chimney stack (**Fig. 3**). The integration of the flashing course with the chimney is further evidence that the chimney and building A were constructed at the same time. Initial examination of plasterwork on the third floor chimney wall revealed that an early yellow plaster had once abutted a sloping feature – possibly a roofline. More evidence for the roof's slope was found on the former west wall, which is now en-

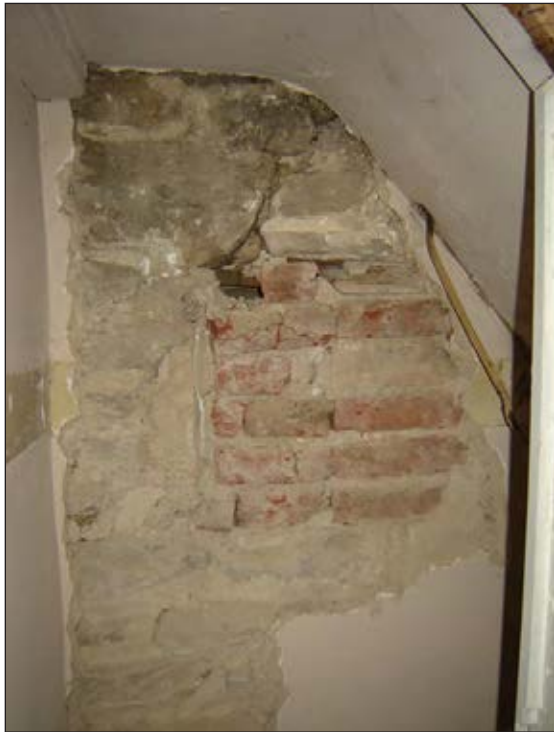
**Figure 4** A bricked up window or vent on the third floor of the old west wall of Sellers Hall. The window was likely covered when a roof for building A was built.

closed by a 1920s-era closet. Plaster was removed to reveal pointing and a bricked-in early vent or window. A piece of wood at the top of the brick in-fill featured an angle cut, which may have been added to follow a roof line. The former vent or window would have been blocked by the roofline and was therefore filled-in when the roof of building A was built (**Fig. 4**).

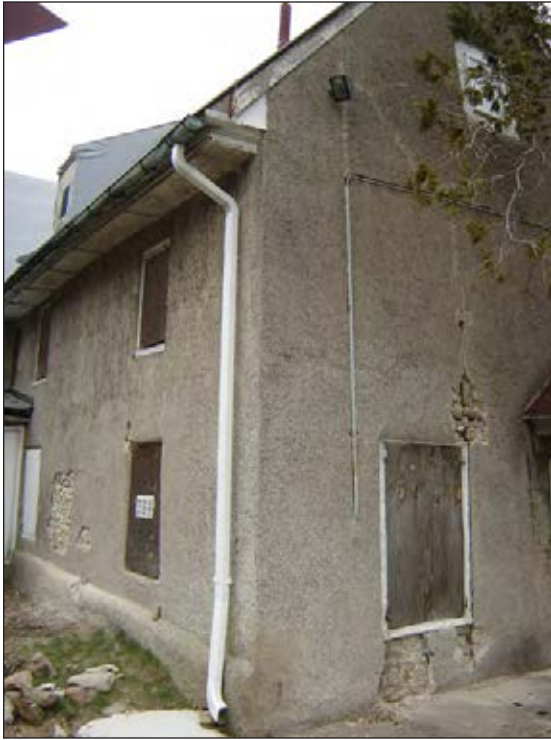
*Figure 5 2011 image of the northwest corner of the western addition – a crack in the stucco of the west face represents a seam between buildings A and B.*

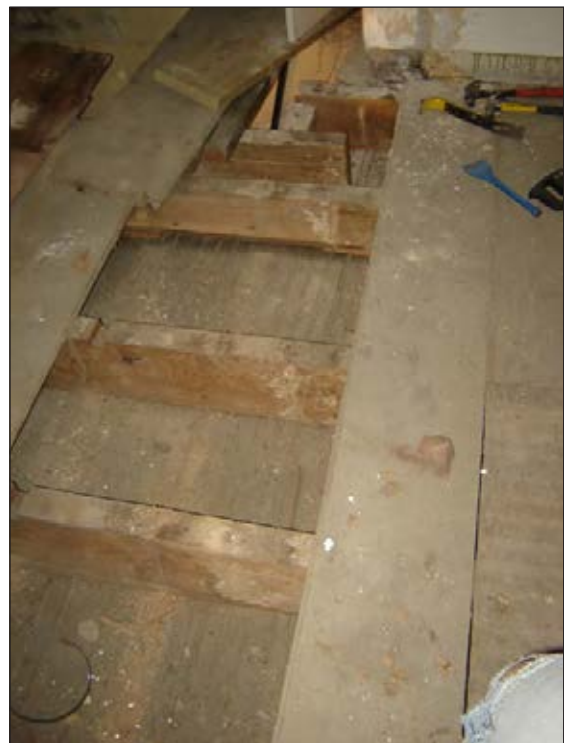
**Figure 7** Third floor joists of the west addition: Faint vertical lines of paint can be seen on the joists in this picture. These lines represent where the joists passed through the former north wall of building A”

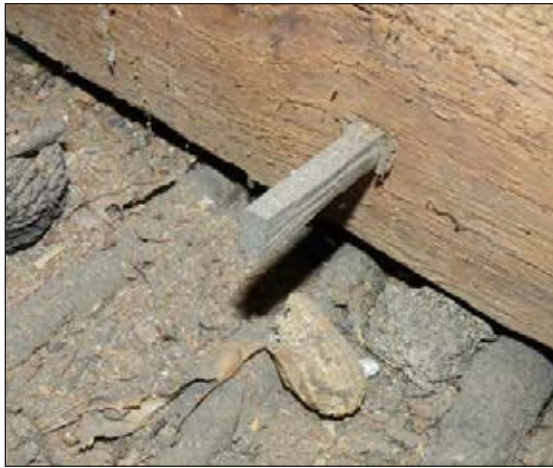
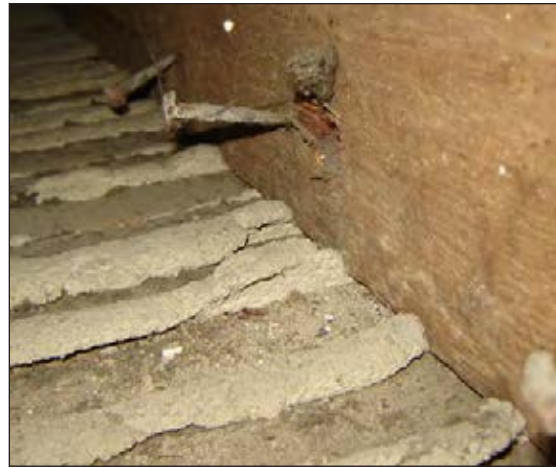
**Figures 8 & 9** These images show two features of the 3rd floor joists of the west addition. Along the sides of the joists there are rows of cut nails with hand wrought heads. There are also oak pegs with a diameter of about  $\frac{1}{4}$ .

The roof over building A was rebuilt to cover both buildings. New joists were added to support a new third floor, which spanned from the south wall of building A to the north wall of building B (**Fig. 6**). Traces of paint and plaster can be found on the sides of these joists, indicating where building A's north wall abutted them (**Fig. 7**). There is a framed opening built into the joists over building A that may have featured a ship-style ladder between the second floor and the third floor attic space. Lines of cut nails with hand formed heads and wood pegs were found in rows on the sides of these

joists. It is possible that they acted to support objects hanging from the 2nd floor ceiling (**Figs. 8 & 9**).

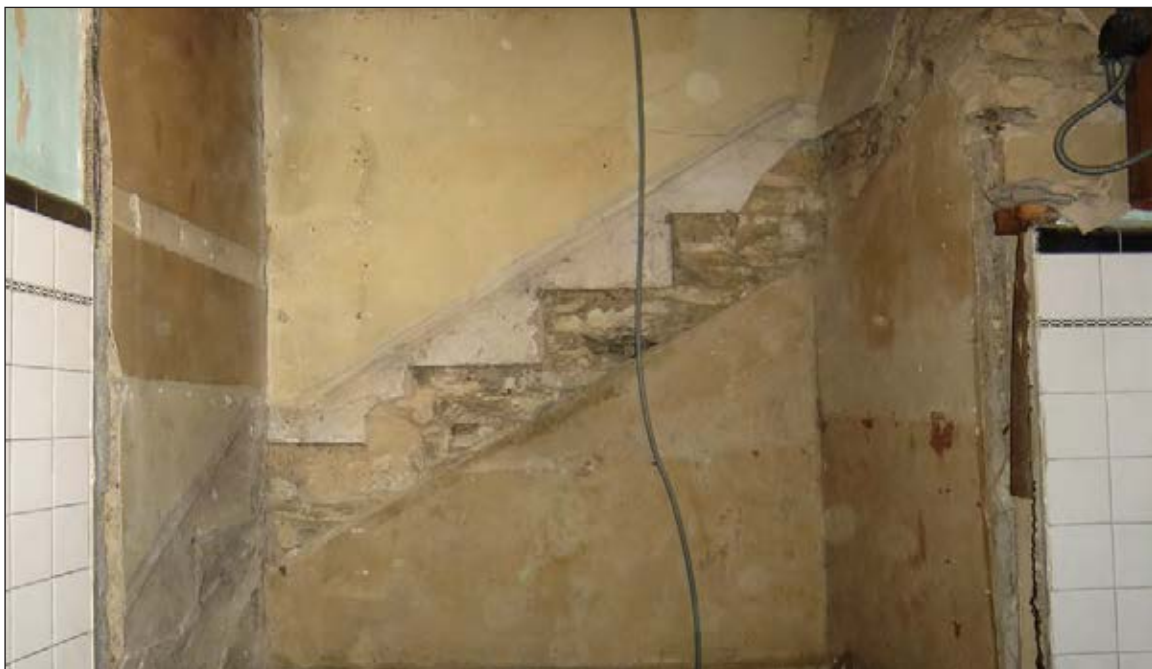
**Figure 10** "In this image shows the outline of a stairway in the east plaster wall of room 203 in the west addition."

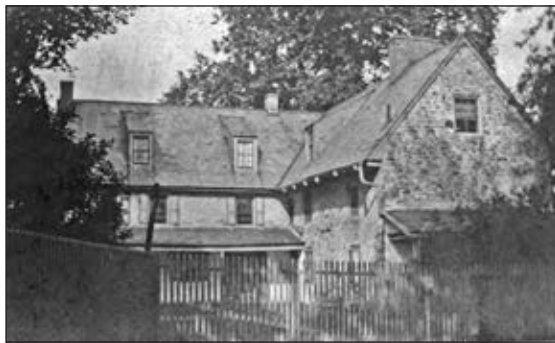
**Figure 11** West end of Sellers Hall in the 1890s showing the complete west addition without stucco.

On the exterior, a porch had been added to the south and west facades of Sellers Hall. The first floor stone walls were white washed. A cast iron plumbing vent stack is visible in the northwest corner of the addition (**Fig. 11**).

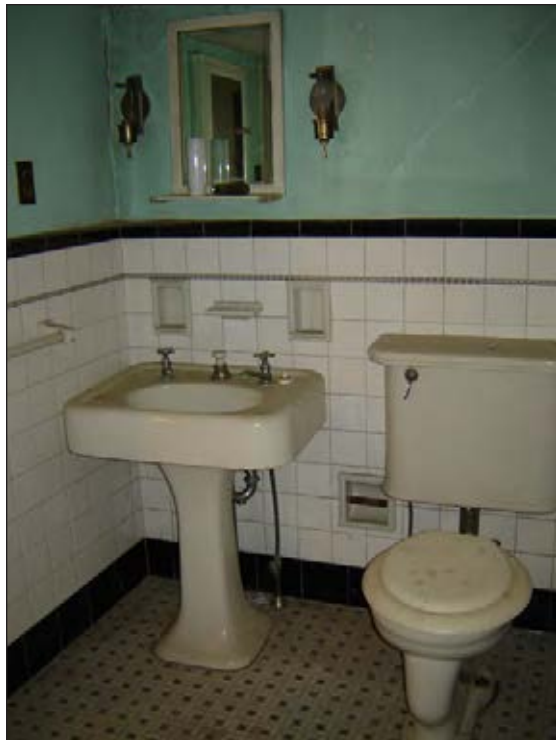
**Figure 12** “Intact 1920s bathroom on the 2nd floor of the west addition”

In any case, the second floor bathroom as it exists today was built in the 1920s. A mosaic porcelain tile floor was set into wet concrete and ceramic wall tile was set into concrete on steel mesh. A stud partition was added in the proximate location of the old stone wall. The partition was covered in 1/4" plywood with a dark green stained finish, which was a new modern building product developed in the 1920s. The extant enameled cast iron pedestal sink is of unknown manufacture, but is a standard design of the 1910s and 1920s. An adjacent

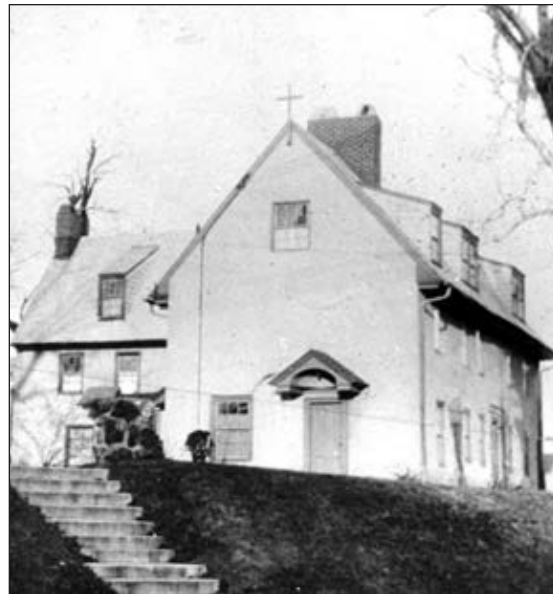
**Figure 12** “West end of Sellers Hall in the 1930s showing the west addition seamlessly blended with the rest of Sellers Hall with a layer of stucco”

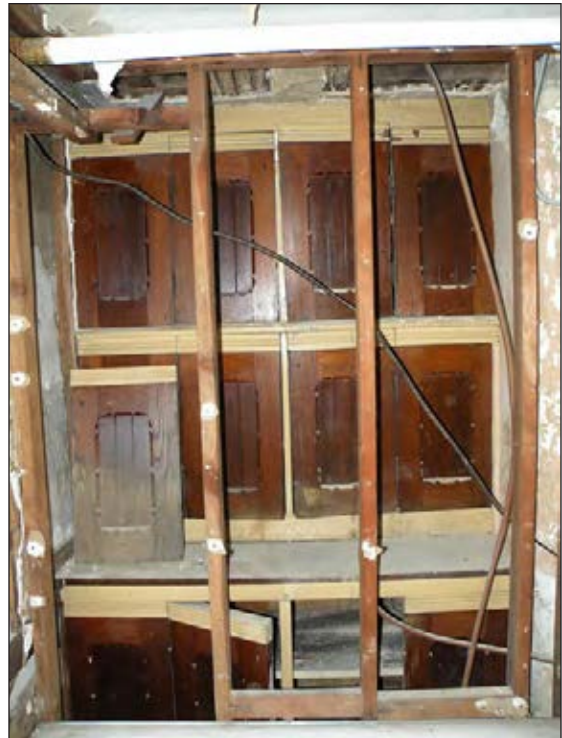
**Figure 13** "1880s oak cabinet hidden since the 1950s or 1960s behind a shower in bathroom of the first floor of the west addition"

Sometime in the 1950s, a bathroom was added to the first floor. The single first floor room was divided at roughly the same location as building A's north wall by a new stud wall. Also, the strip oak flooring was covered in 8" x 8" grey linoleum vinyl tile. In the new bathroom, a wall sink and medicine cabinet, an older 1930s toilet, and a tub/shower were installed. The shower was placed in front of the 1880s oak cabinet and a new stud wall was built between the tub and the cabinet. The cabinet remained concealed until initial investigation revealed it in 2010 (**Fig. 13**).<sup>12</sup>

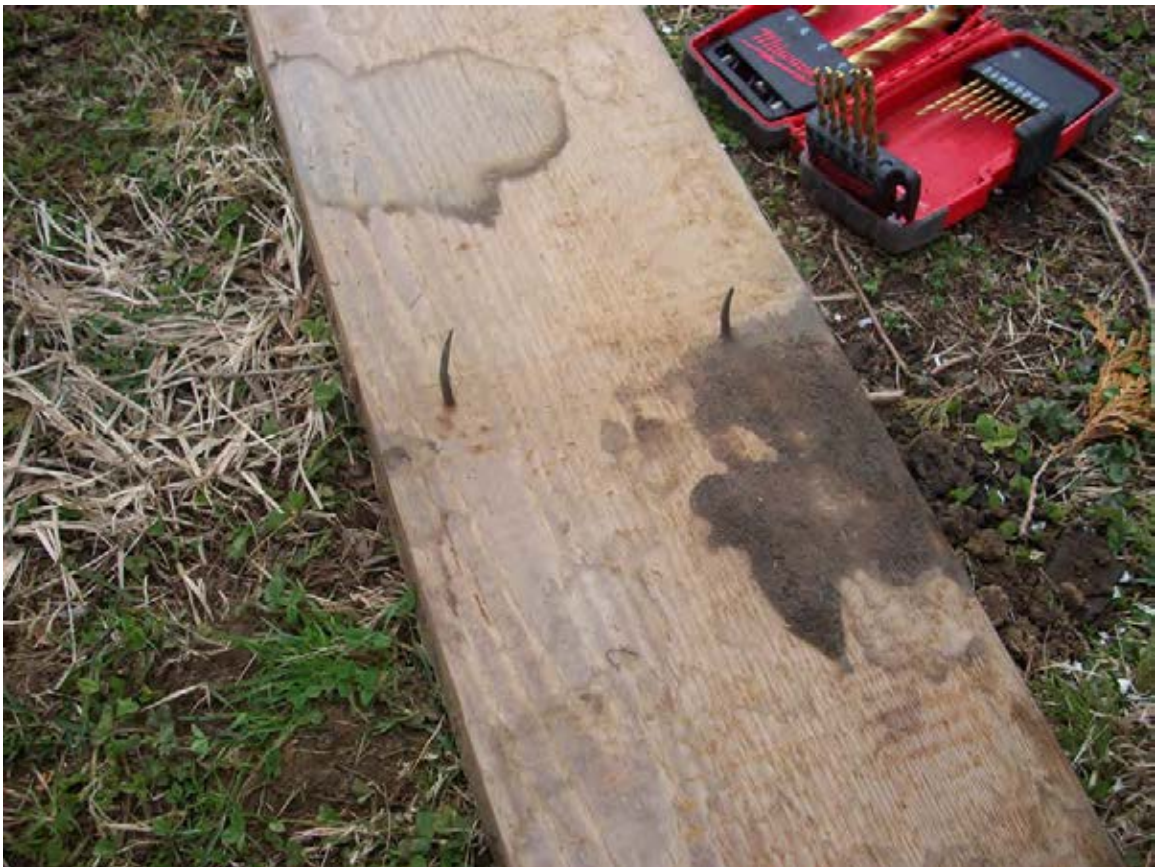
**Figure 1** The soffit board of the original cornice.

Sellers Hall retains structural and architectural elements from its initial construction through the early-19th century. The majority of the random rubble stone walls from the original structure and from subsequent additions remain, though obscured by stucco. While the roof was rebuilt, the original oak cornice still crowns the south façade. On the interior, major oak structural elements such as the summer beam and chimney girt continue to support the house. Other structural members, such as oak joists and roof framing, exhibit finishing and joinery techniques common to the 18th-century.

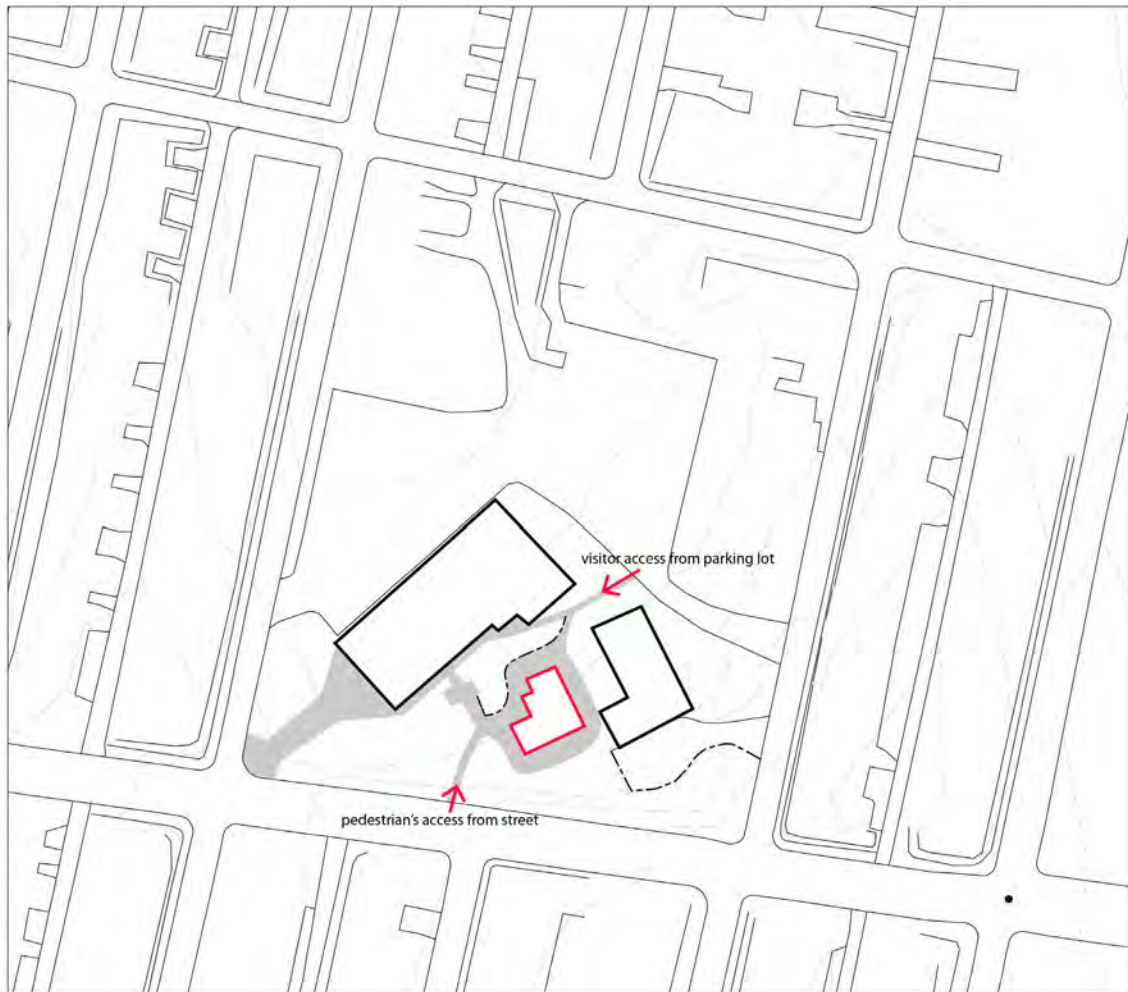
**Figure 1** Proposed plan for Sellers Hall.

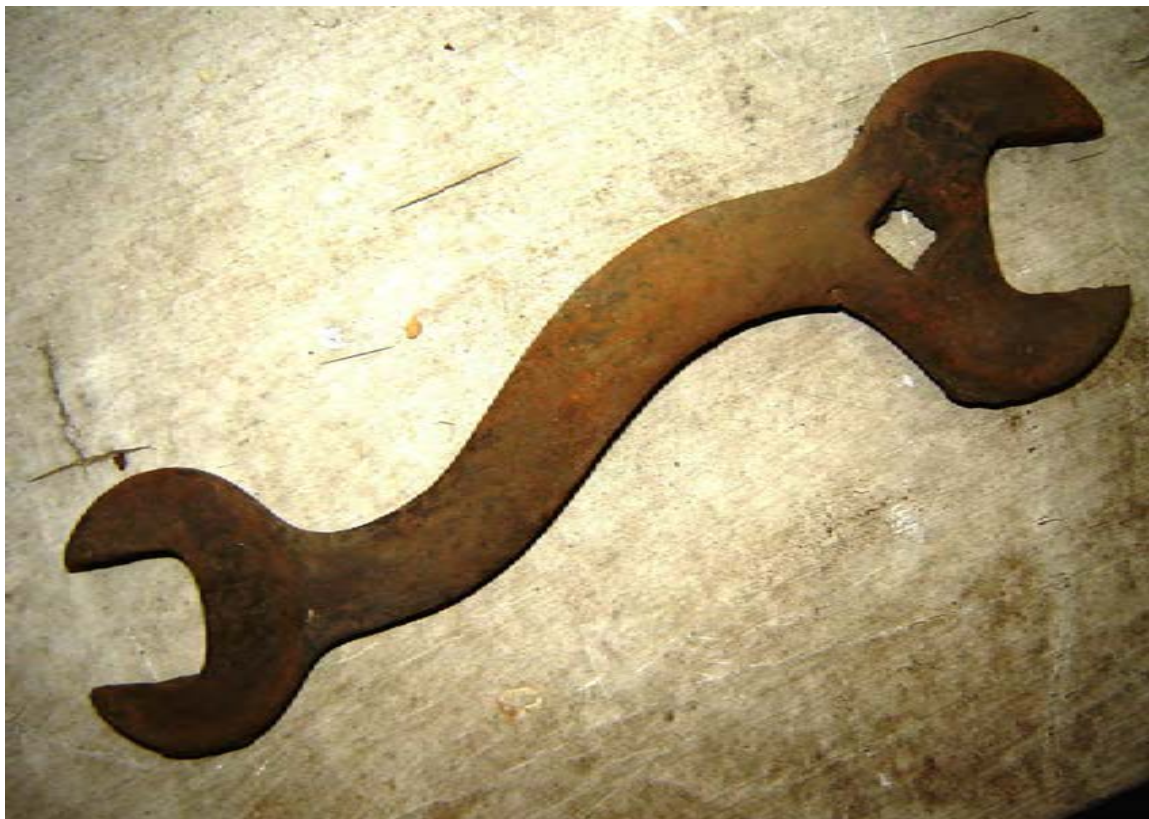
### WRENCH “509”

The wrench features the number “509” at one end and has a small square hole at the other. This hole is common for plumbing wrenches and was often built into a wrench for use on radiators. The square opening fits most radiator valves, and indeed likely fits other knob-less valves. The wrench was found under a floor that had been nailed down originally with cut nails and re attached with wire nails. The presence of the wrench, the nails, and newspaper dated 1914 help to date when the floor of Room 303 was taken up. The wrench was likely dropped in the floor when work was done on the radiator in the room. The radiator may have been replaced or moved. A section of newspaper from 1914, found wedged between and under the floorboards, likely dates the work to that year. The wrench is cast metal and likely dates to the 1880s or 1890s.

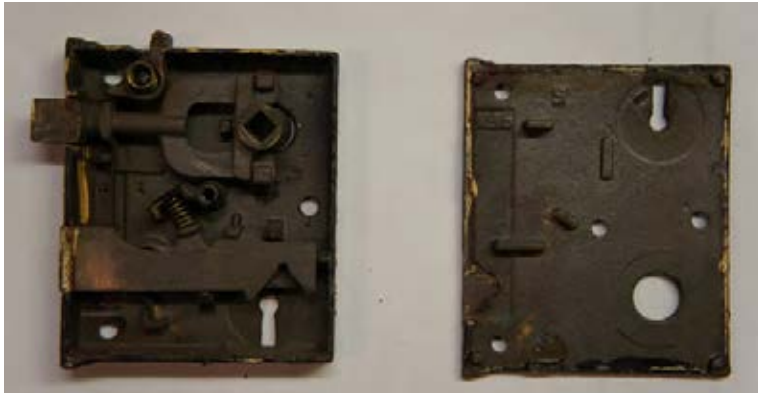
*Interior*

### *Vertical Rim Lock*

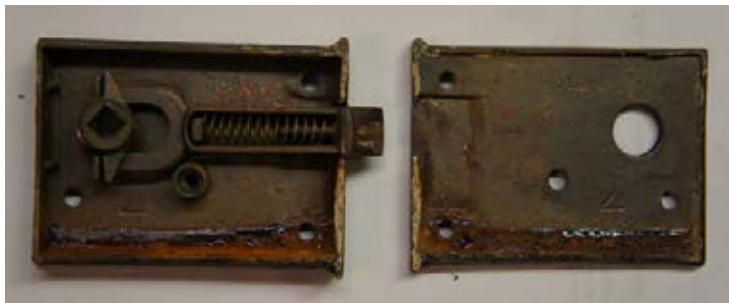
*Interior*

### *Horizontal Rim Lock*

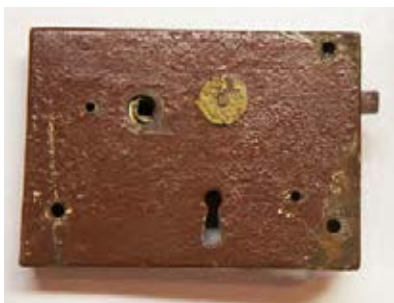
*Interior*

### *Carpenters Lock*

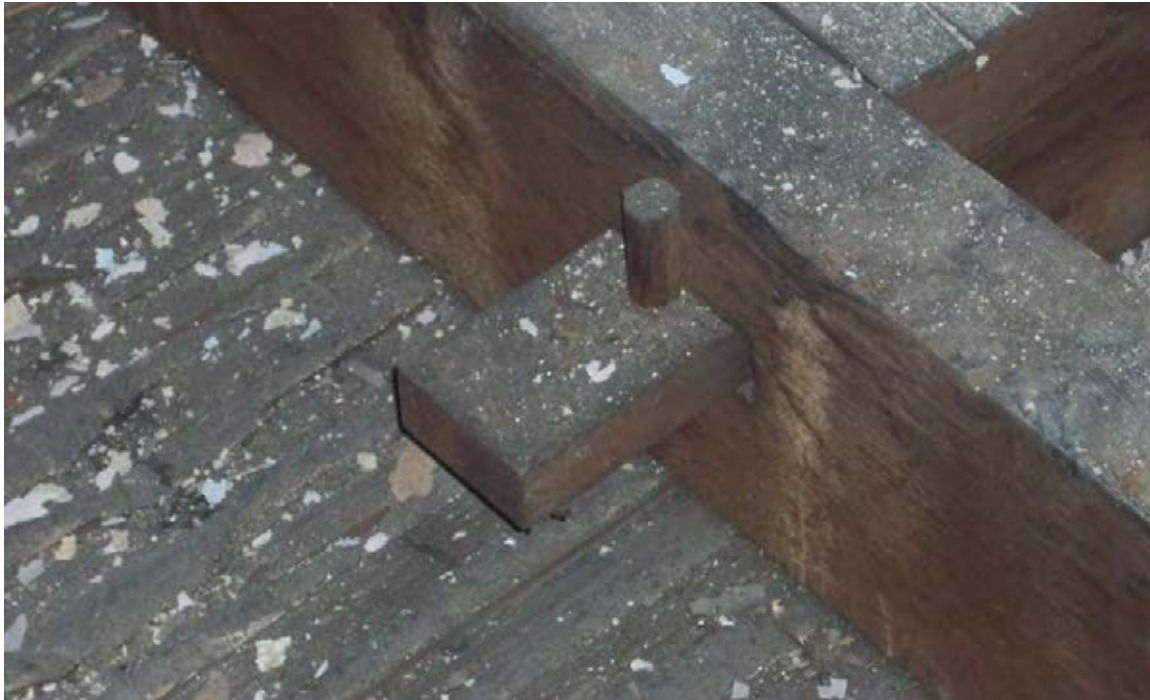
*This is an example of a later mortise and tenon joint with peg. The original mortise and tenons have a diminishing shoulder, or slant, above the tenon. This method reduced the amount of material cut, providing for a stronger tenon.*

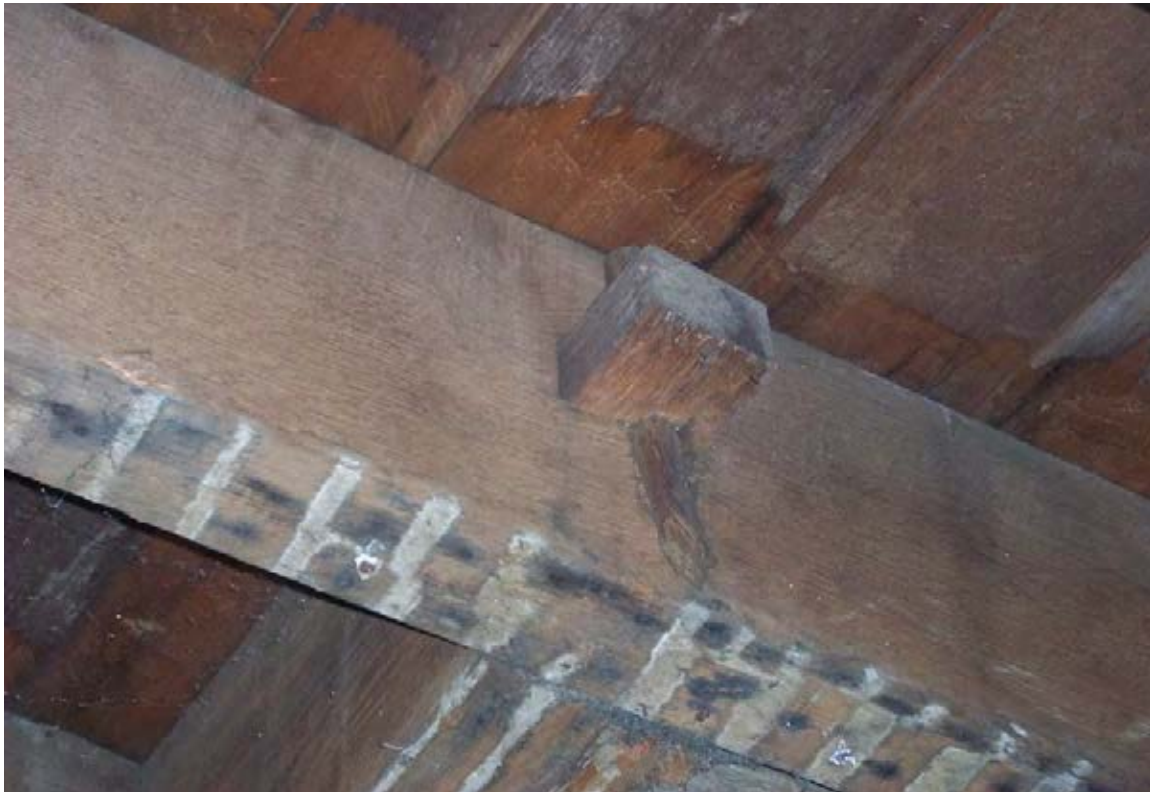
*This mortise and tenon joint with peg is used to in-fill the staircase opening.*

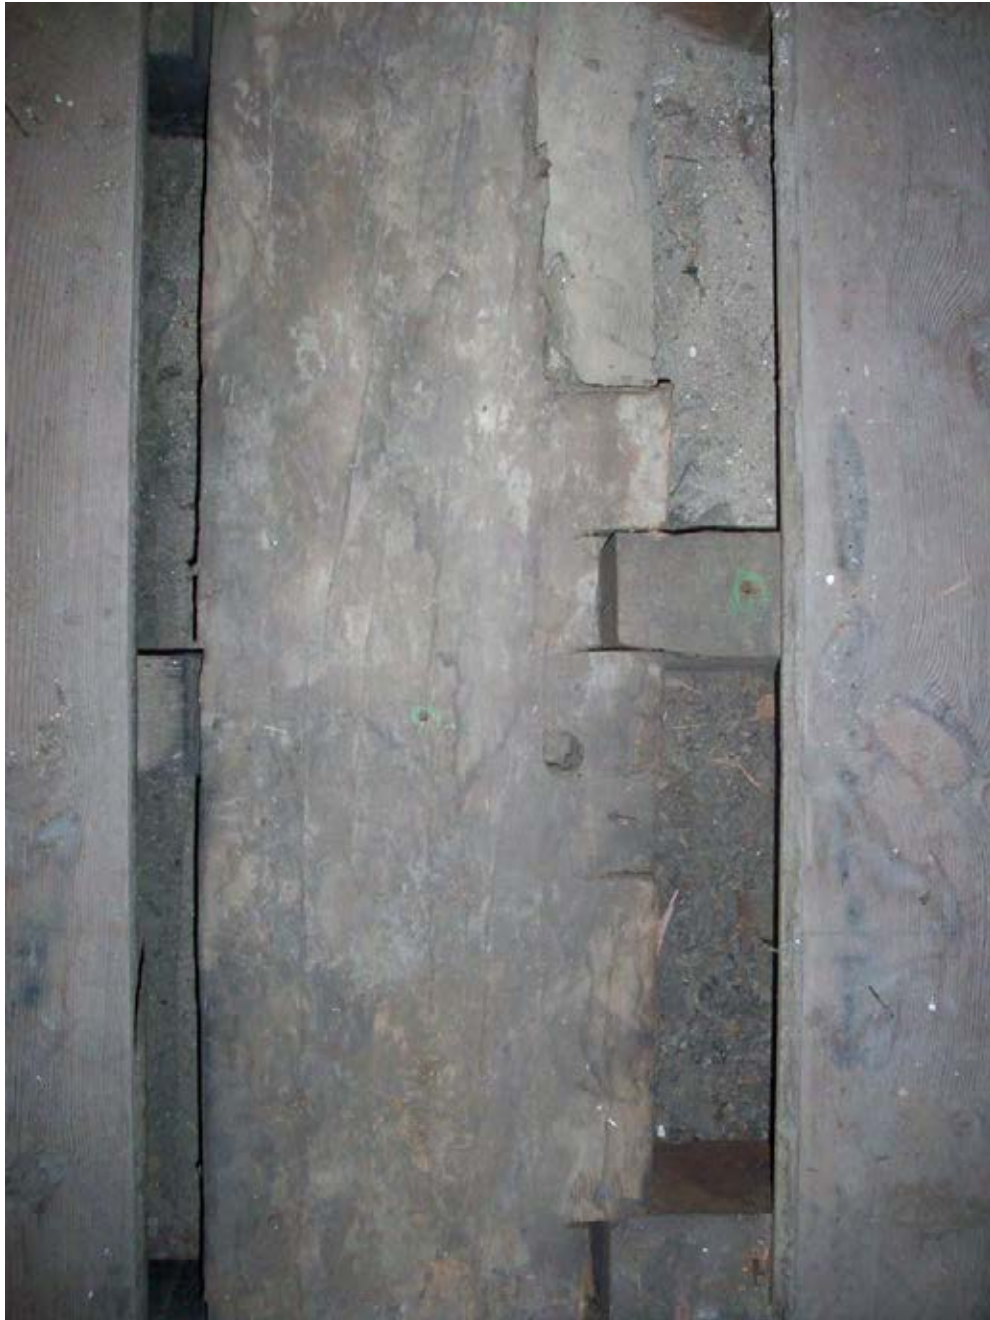
*Original joists, pictured on the left of the chimney girt, are cogged with a diminishing shoulder. There are no pockets cut into the chimney girt on the opposite side, the west side, where it would've abutted the masonry of the original cooking chimney. Joists on the left side are resting on cleats.*

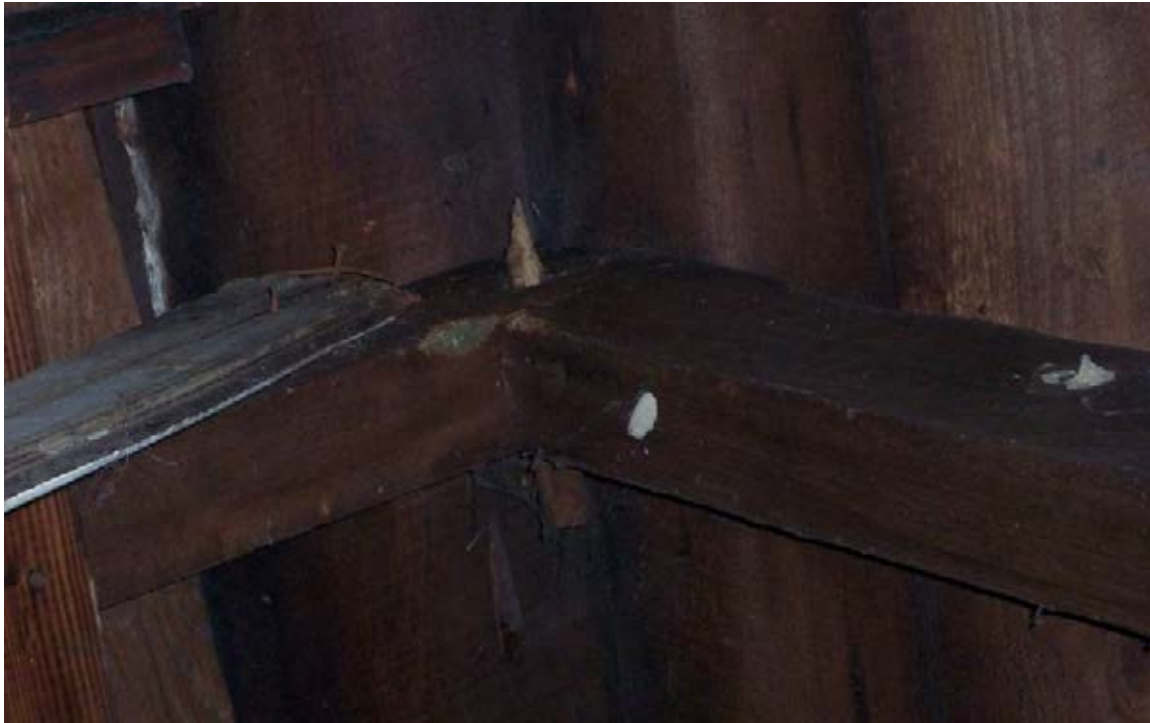
*The roof rafters are connected at the ridge by a bridled joint and peg.*

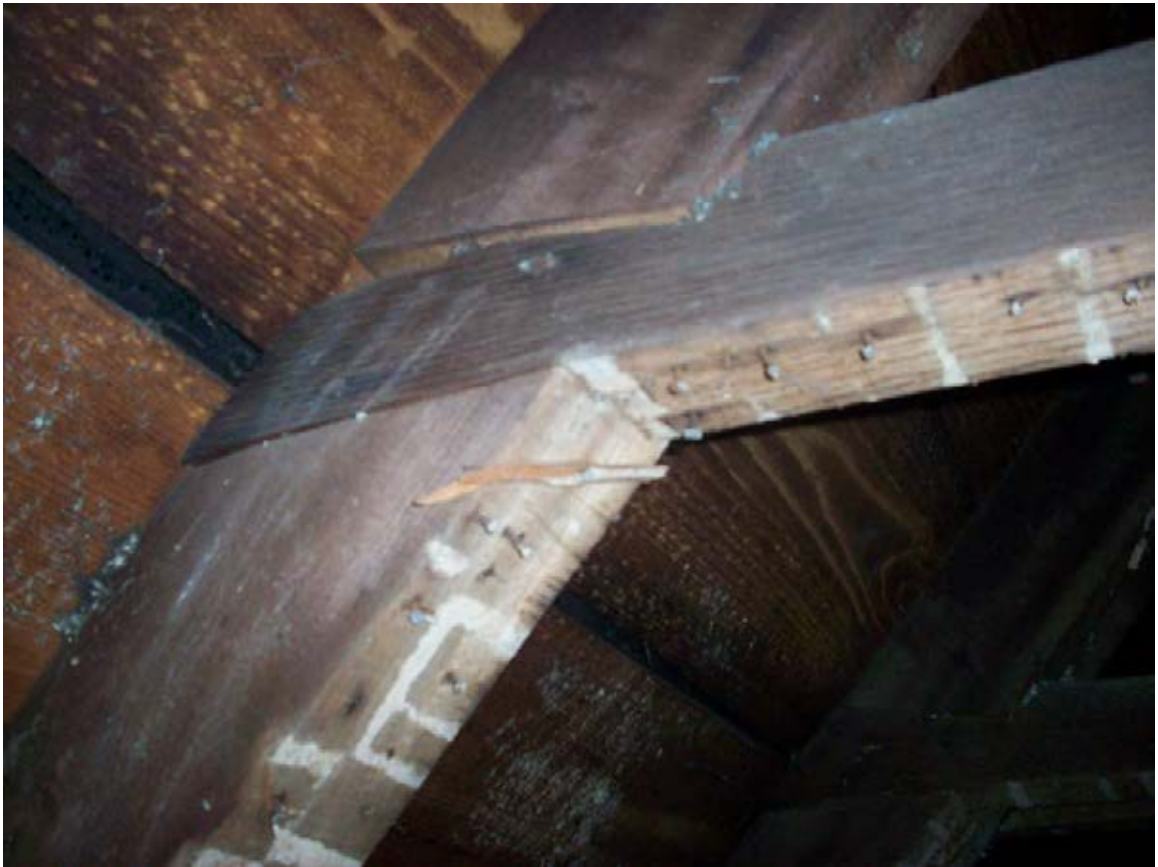
*Tie members in the roof are connected to the rafters with a dovetail joint.*

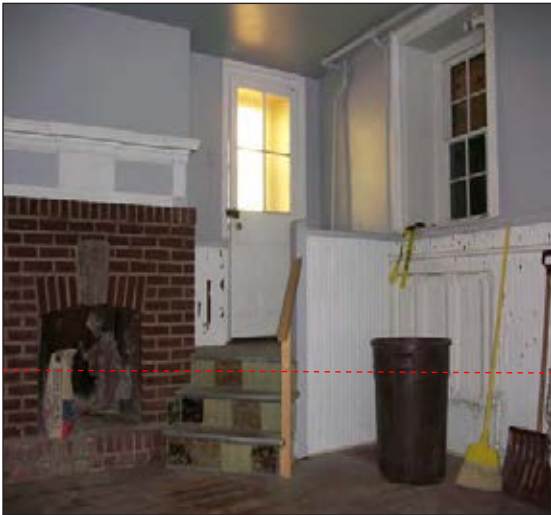
**Figure 1** Red line indicates original floor height, 2010.

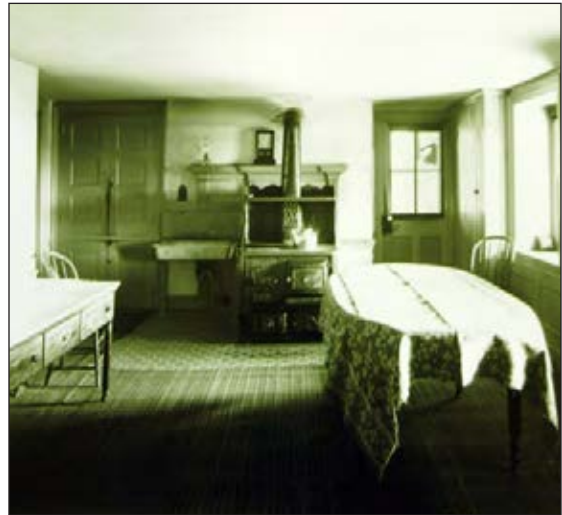
**Figure 2** Original height of floor. This photo shows the same fireplace and doorway depicted above. (Delaware County Historical Society, 1906)

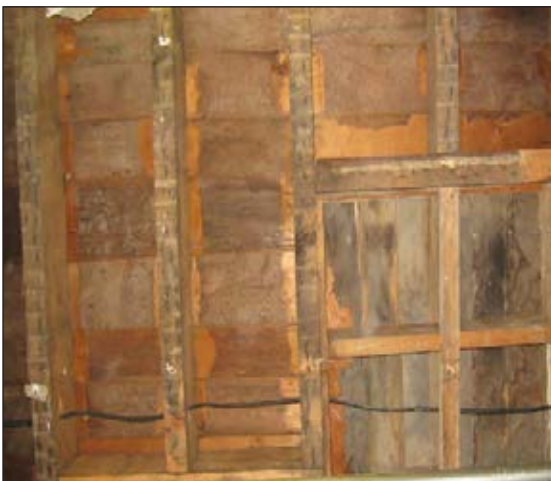
**Figure 3** Framed opening in room 106, 2010.

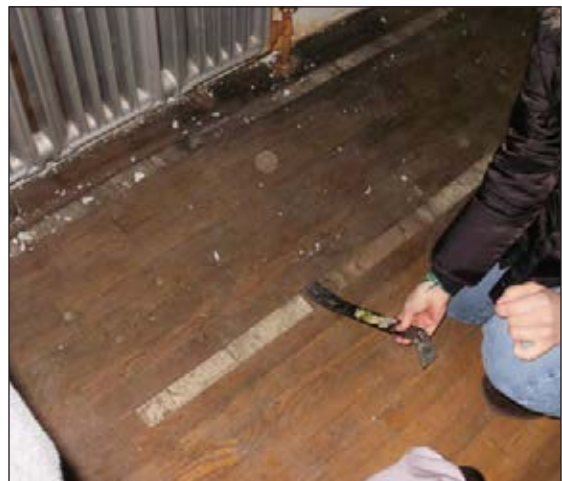
**Figure 4** Removal of modern strip flooring in room 202, 2010.

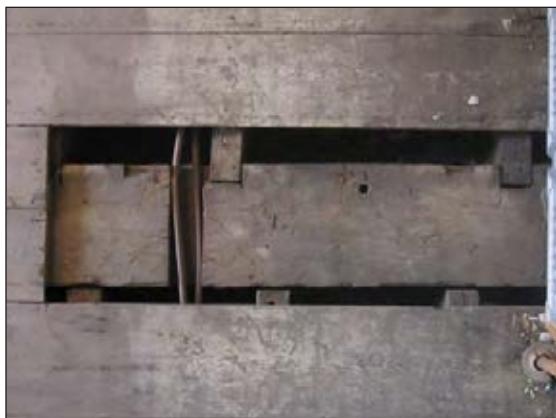
**Figure 5** Chimney girt in room 202, 2010.
