# *Sellers Hall*

## Upper Darby, Pennsylvania

A report compiling the archival and architectural research of Sellers Hall, from the spring terms of 2010 and 2011. Prepared by the Architectural Archaeology Class of the Graduate Program in Historic Preservation—School of Design, The University of Pennsylvania.

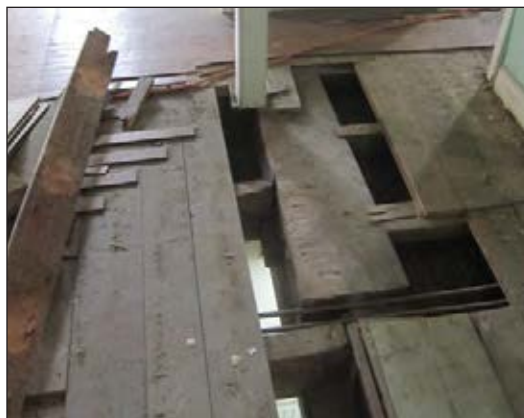
**Figure 6** Summer beam in room 201, 2010.

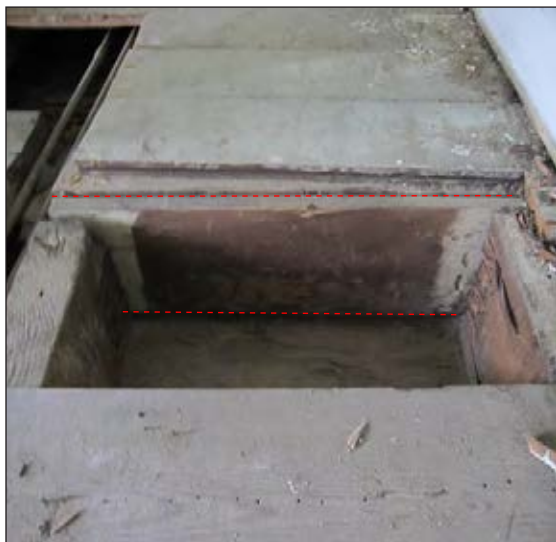
**Figure 7** Original stair riser on summer beam in room 201, 2010.

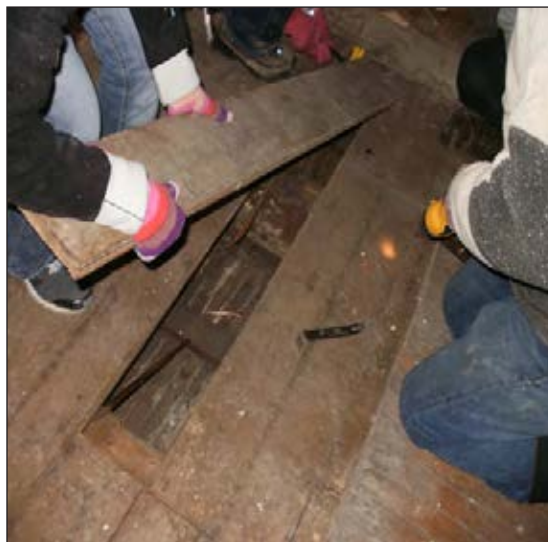
**Figure 8** Removal of floor boards in room 302, 2010.

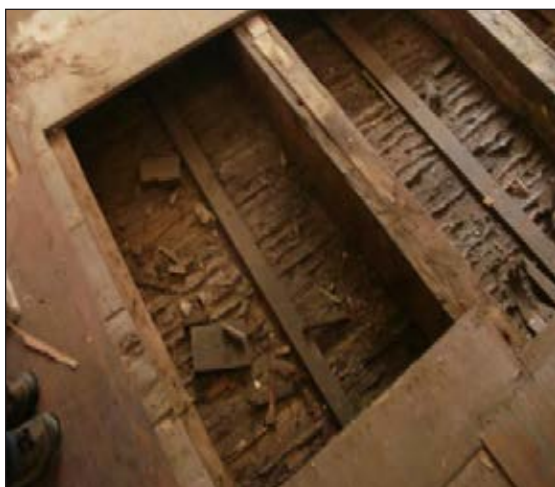
*Figure 9* Floor Joists running north/south in room 302, 2010.

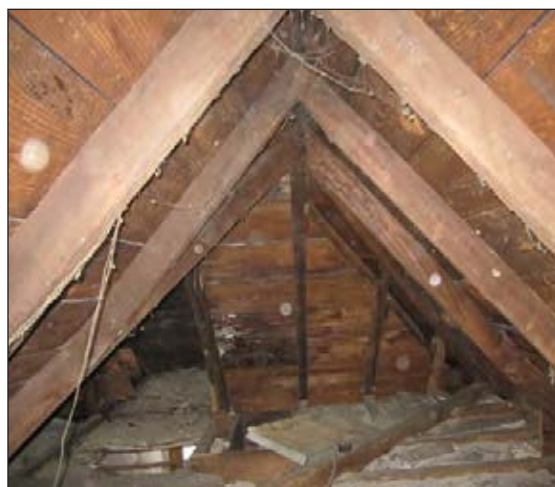
*Figure 10* Attic rafters, 2010.

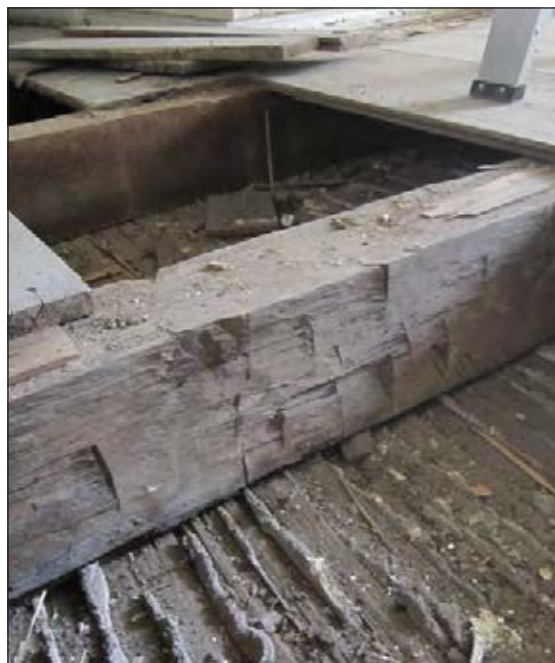
*Figure 12* Hand hewn joist room 302, 2010.

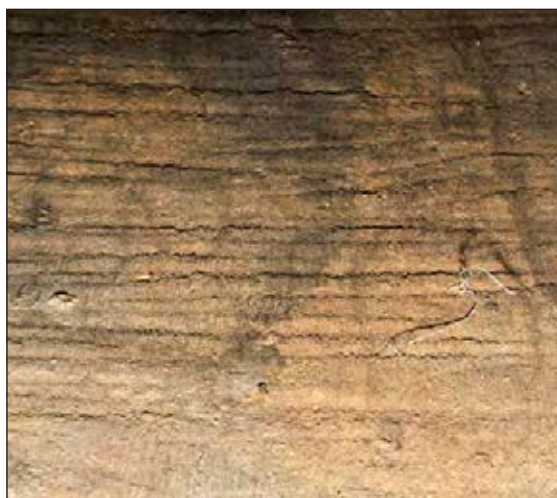
**Figure 13** Pit saw marks, 2010.

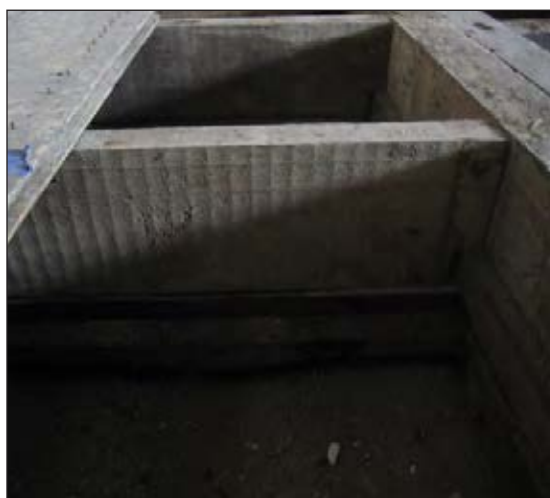
**Figure 14** Vertical sawmill marks, 2010.

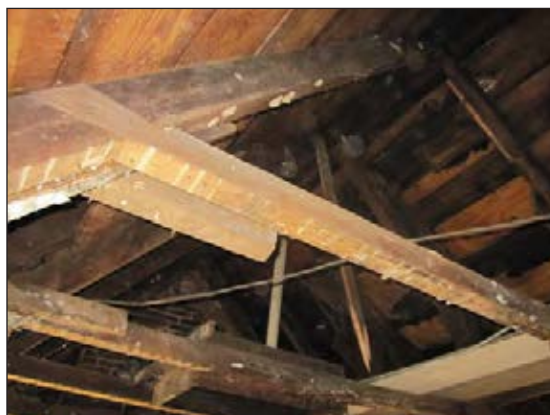
**Figure 16** Roofing system - rafters and collar ties, room 301, 2010.

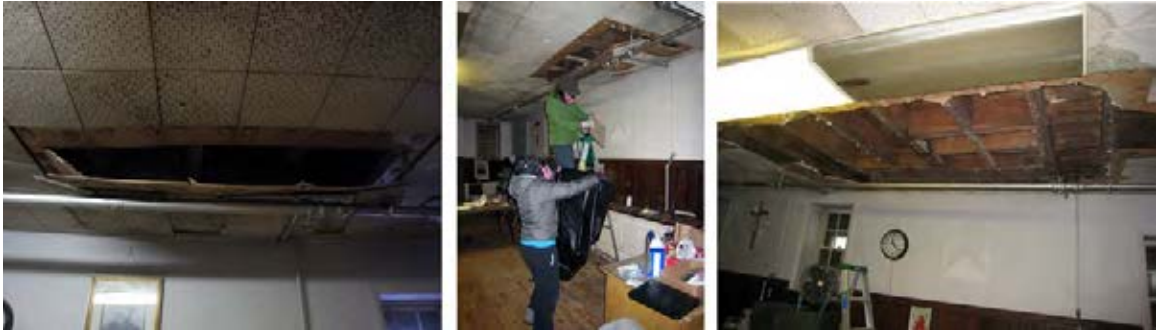
**Figure 1** Framing of Rm 106; before, during and after ceiling removal, 2010.

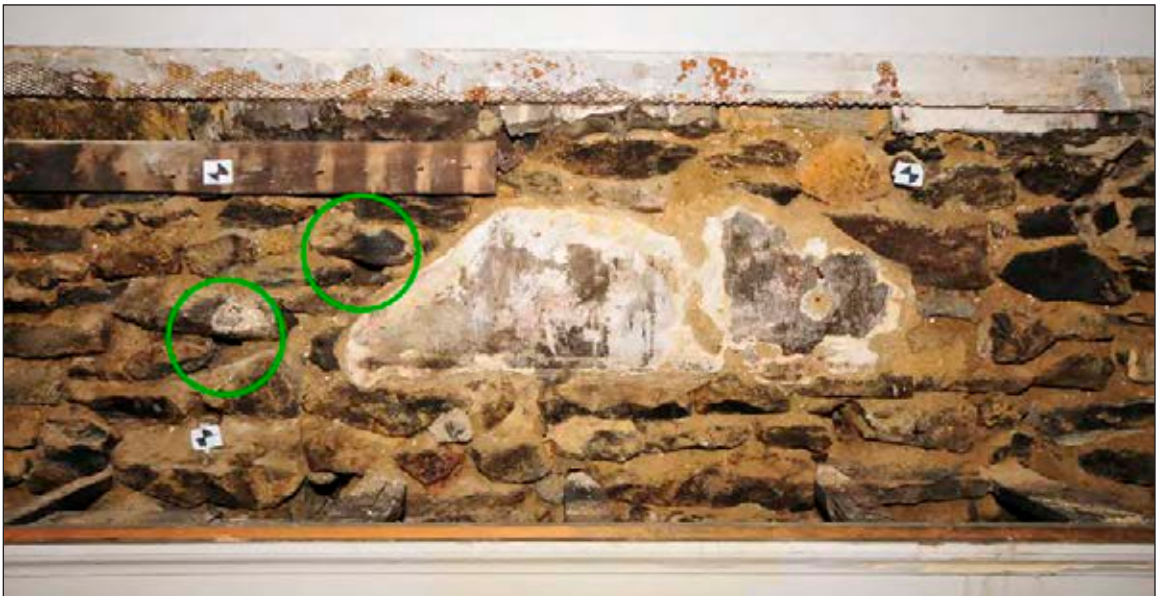
**Figure 3** Interior elevation of east wall, exhibiting staircase evidence, 2010.

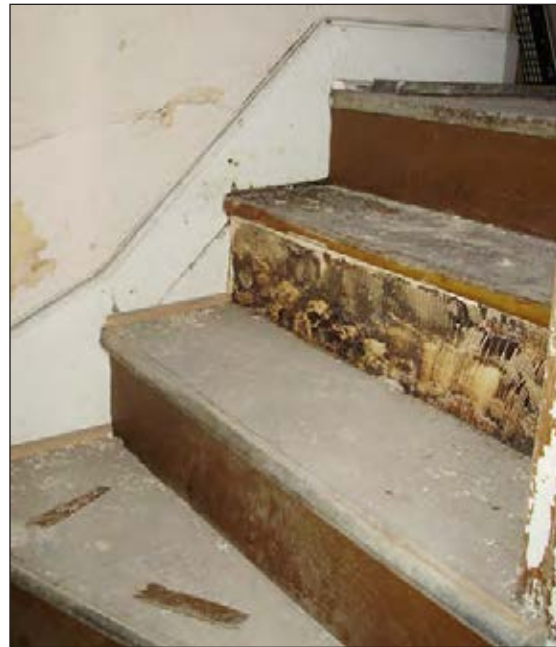
**Figure 5** Three original steps at the top of the stairs on the third floor, 2010.

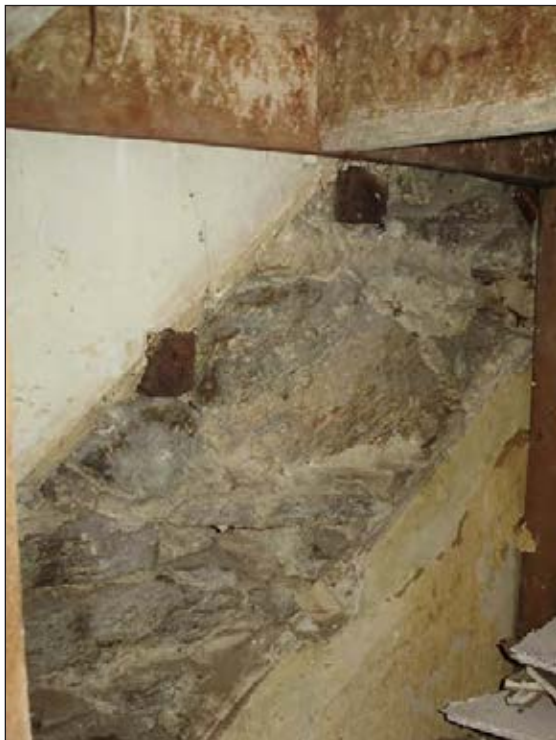
**Figure 6:** Plaster outline below the current stairs on the third floor, 2010.

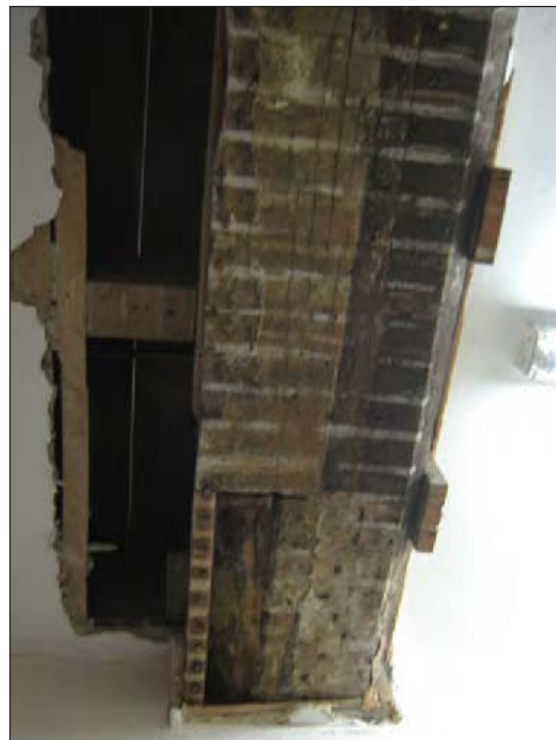
**Chamfered section of the summer beam, 2010.**

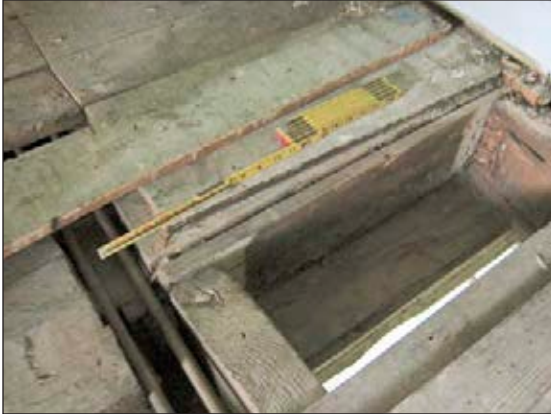
**Figure 8** Riser board attached to the summer beam, view from second floor, 2010.
